# TIRPITZ

An account of the various attacks  
carried out by the British Armed  
Forces and their effect upon the  
German Battleship

Volume 1  
REPORT AND APPENDICES

1948

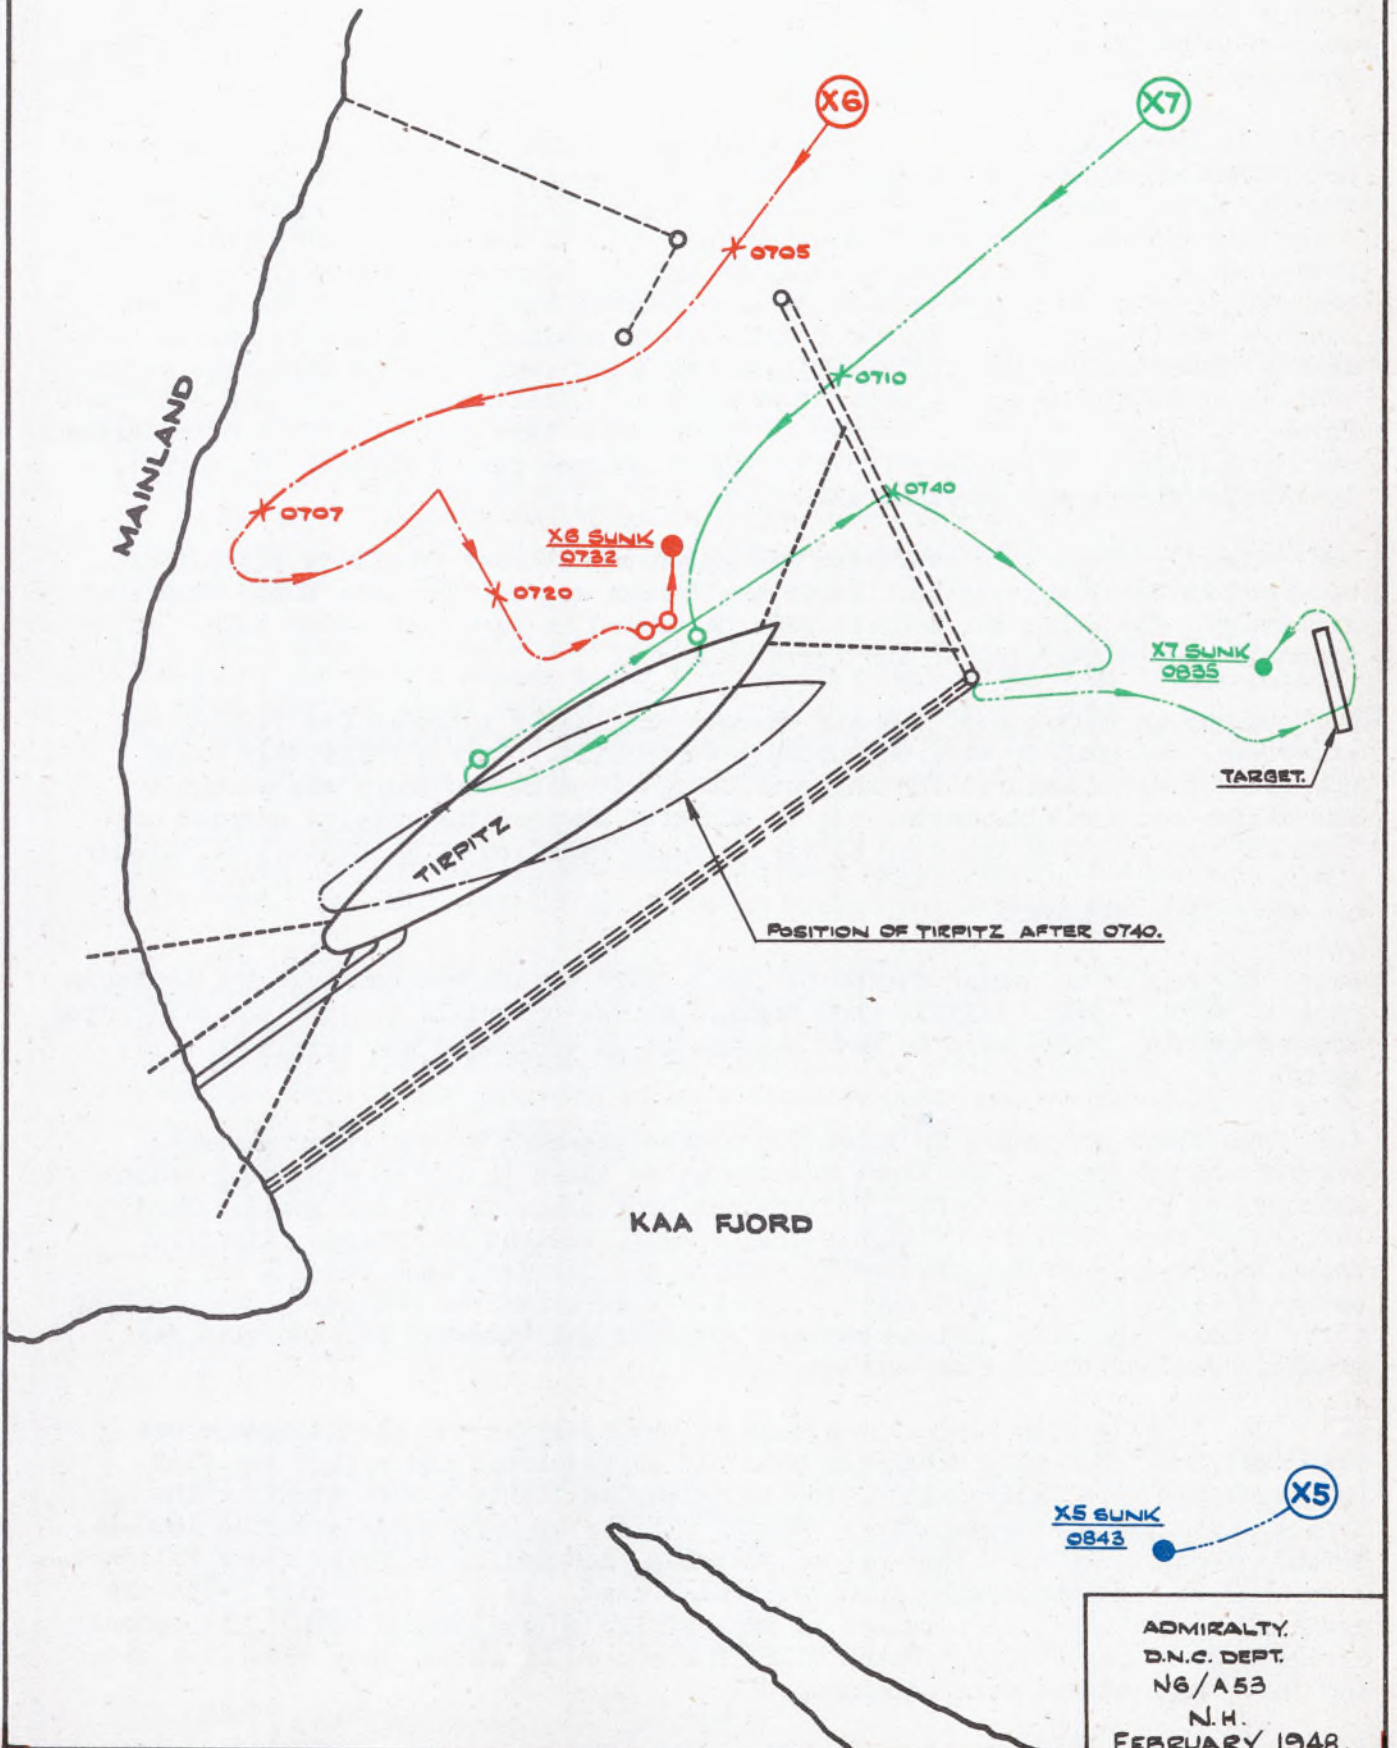
**TIRPITZ.**  
**OPERATION SOURCE.**  
**TRACK CHART OF X-CRAFT.**  
**SCALE: 1 IN. TO 220 FT.**

3.4 X.6 entered the torpedo net enclosure around TIRPITZ at about 0705 G.M.T. using the official entrance which was open at the time for the passage of store ships (see Figure 3). After a series of instrumental defects had caused her to surface three times (she was mistaken for a porpoise on the first occasion, correctly identified on the second (at 0710) and attacked with machine-gun fire and hand grenades on the third), X.6 succeeded in releasing her two charges under the ship abreast 'B' turret. As escape was then impossible, she was scuttled and her crew surrendered. Meanwhile, X.7 endeavoured to penetrate the net defence by passing under it. She experienced a number of setbacks but eventually succeeded in entering the anchorage. Passing down it under the keel of TIRPITZ, from forward to aft, she released one charge abreast 'B' turret and the other further aft, under the after Engine Room. This 'X'-Craft left the enclosure at 0740, this time sliding over the nets, and then dived. During the manoeuvre she was sighted by the Germans and hit several times with machine-gun bullets. At 0812, while still submerged, the crew heard a tremendous explosion which they thought to be due to the explosion of the 'X'-Craft charges. X.7 subsequently became uncontrolled; it was decided to scuttle her and at 0835 she was brought to the surface, but sank again with her hatch open after only one member of the crew had managed to escape. The full movements of X.5 are not known but she was seen at 0835 on the surface some 500 yards outside the nets, when she was fired upon by TIRPITZ and appeared to sink.

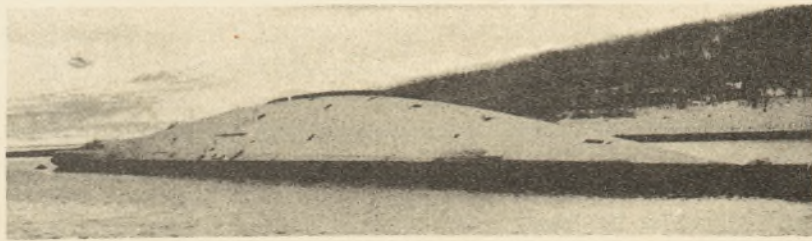
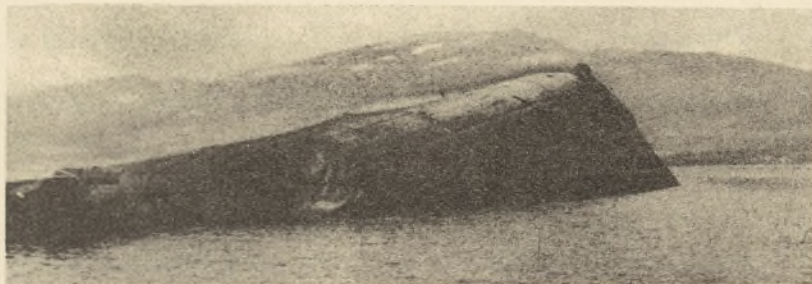
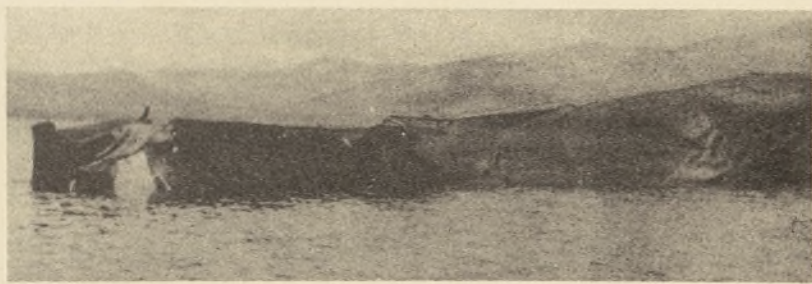
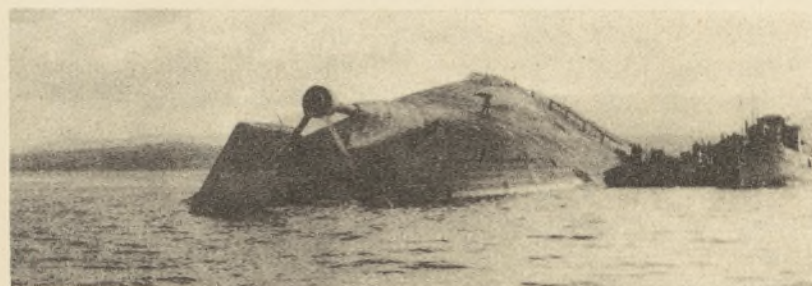
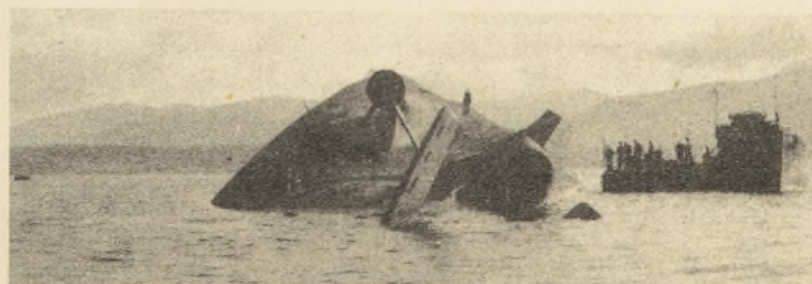
Plate B.1

General views of capsized ship.

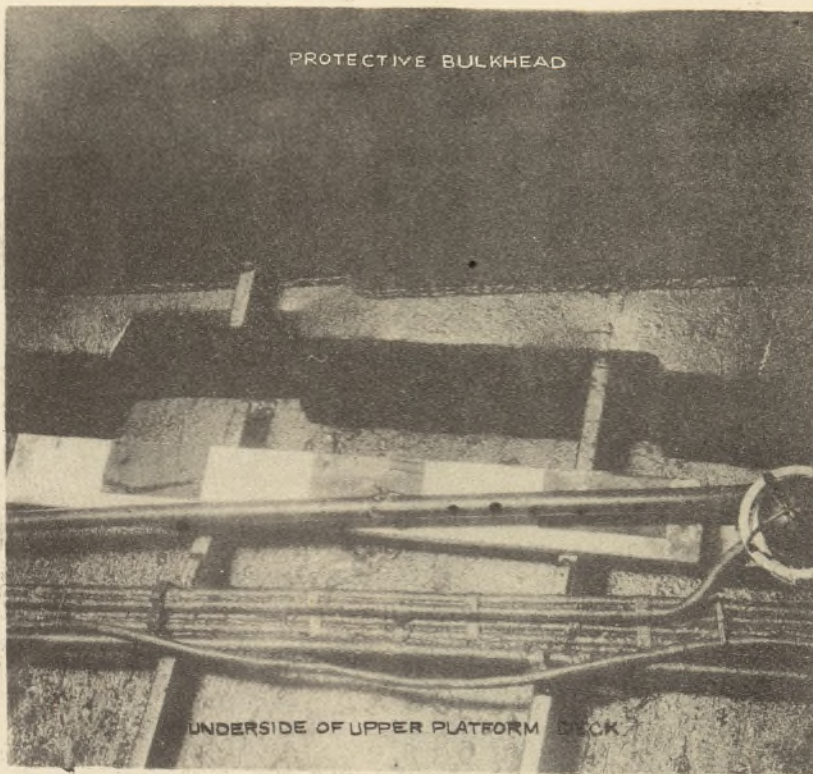
Damage due to internal explosion.

Crack in deck.  
(See ① fig.B.4.2)

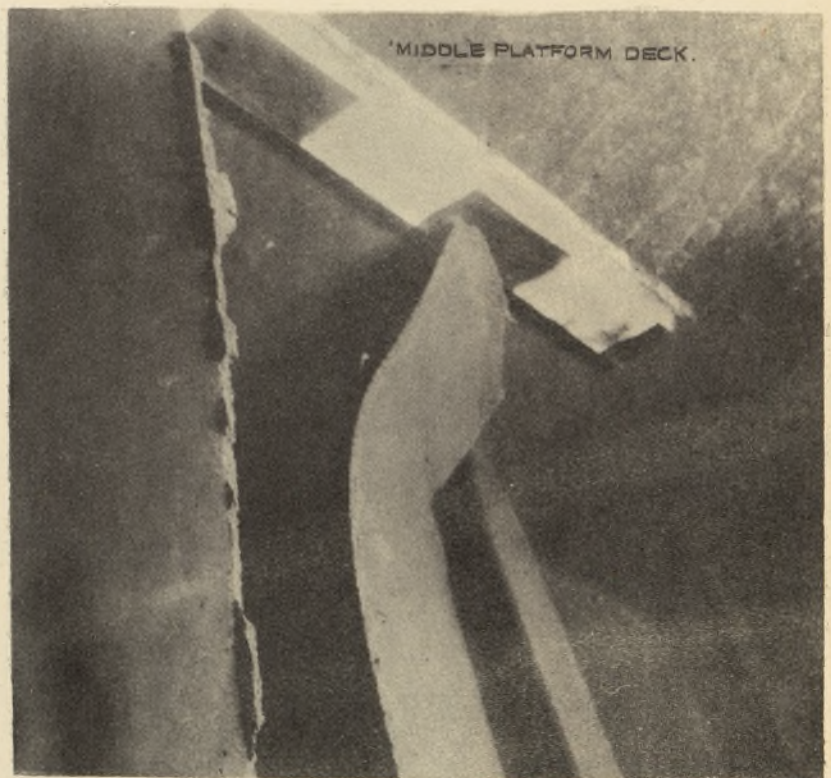
Bulkhead to  
shell room  
between C and  
D turrets blown  
out; crack down  
line of welding.  
(See ② fig.B.4.2.)

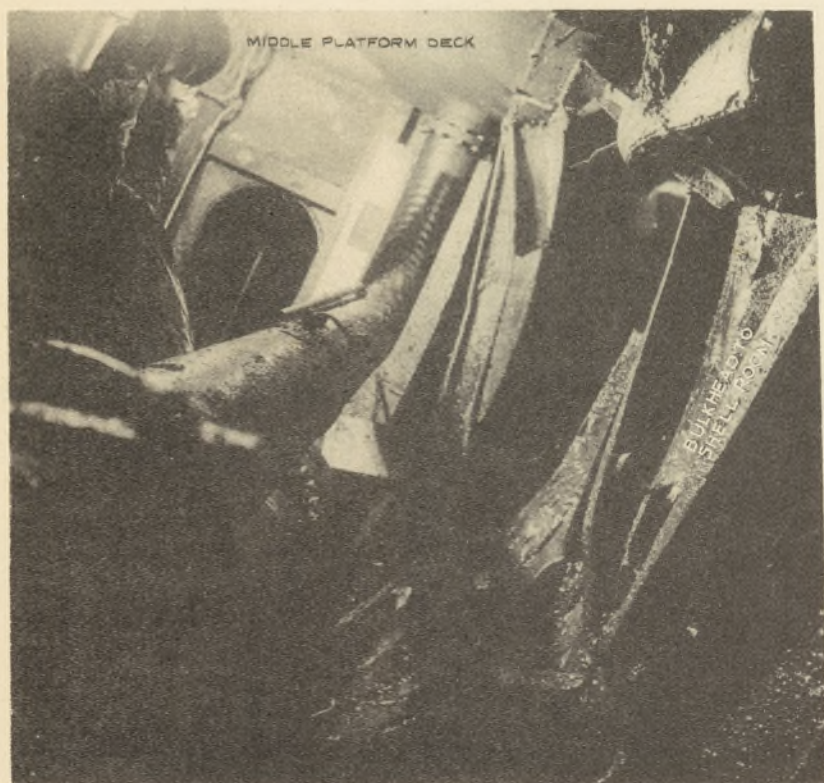
Port cable passage on Middle Platform deck (Section III).

Shell room bulkhead fractured along line of vertical welding and blown in-board.

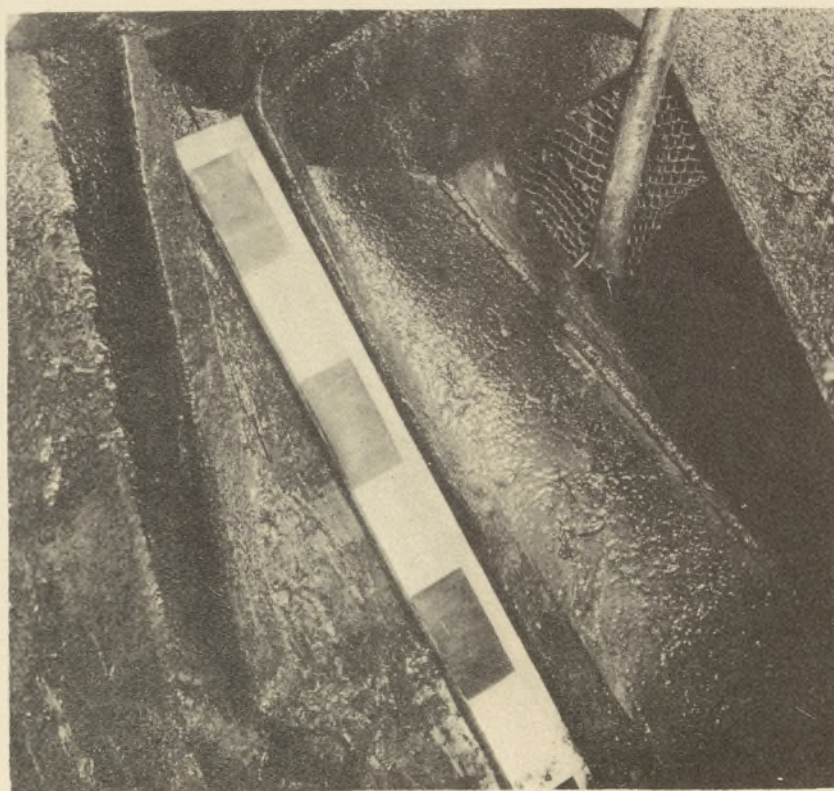
(See ③ fig.B.4.2)

Hole in transverse bulkhead.

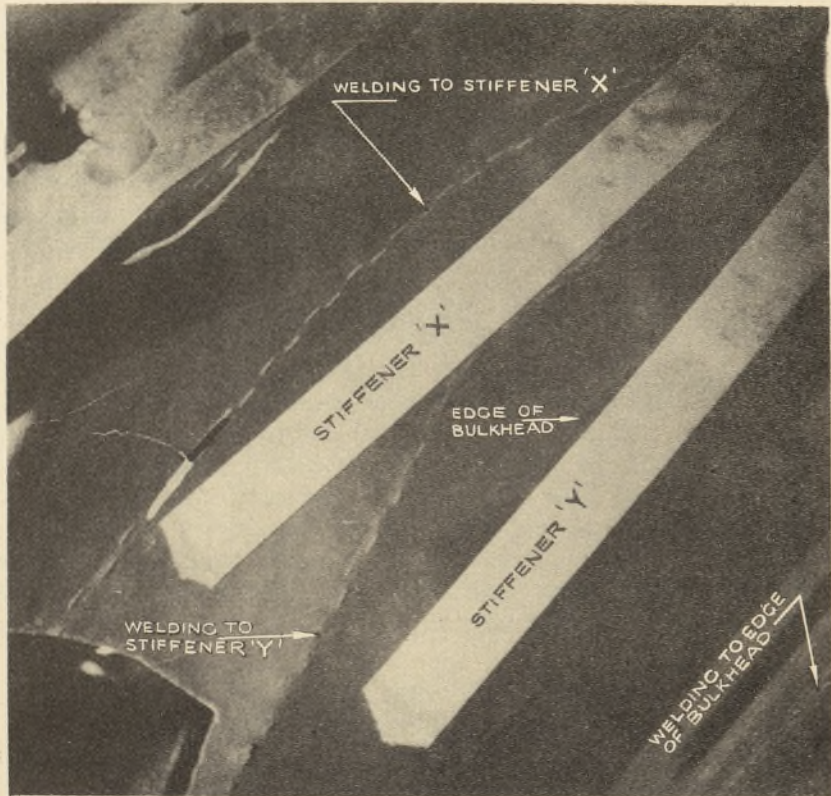
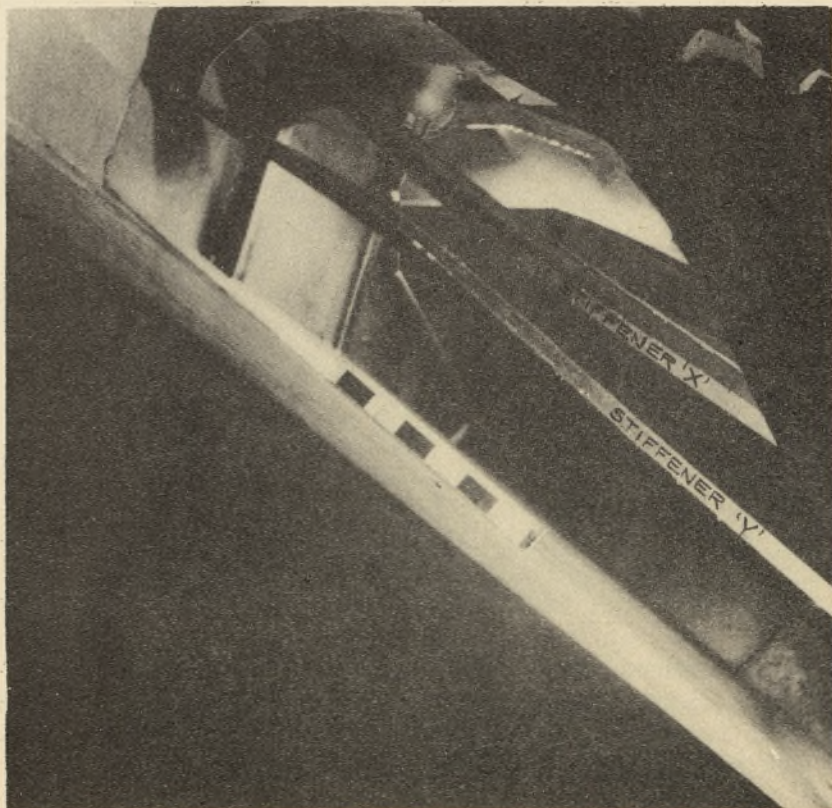
Transverse bulkhead blown away  
from stiffeners, leaving stiffeners  
in original position.

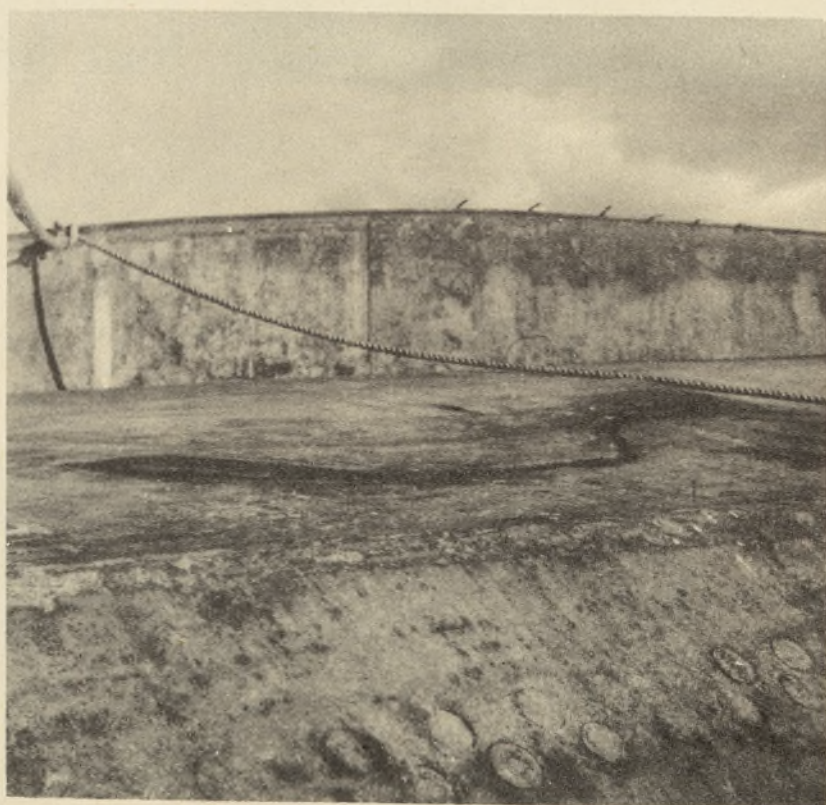
Damage to outer bottom plating  
due to 1,600 lb. A.P. bomb (Fleet  
Air Arm attack on 3<sup>rd</sup> April 1944;  
-Hit No. XII).

Crack made good by driving in  
liners, and by under water  
welding.

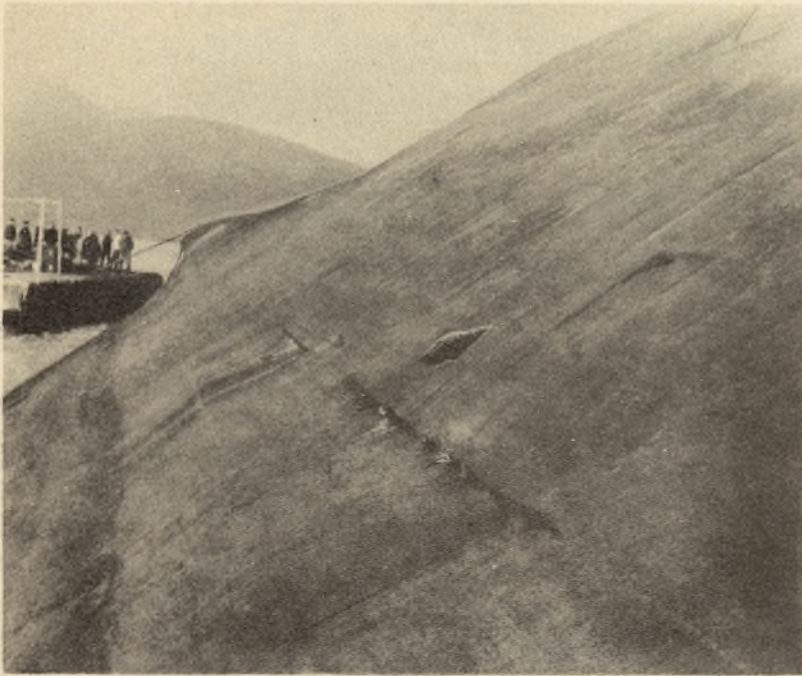
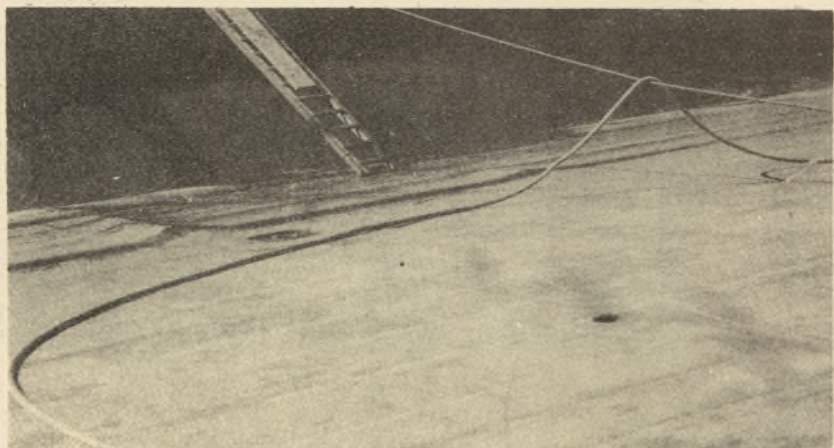
Views of damage probably due to  
the X-Craft attack (22<sup>nd</sup> Sept. 1943).

Crack in weld  
and dishing in  
flat keel plating.

Buckling of  
flat bottom  
plating due  
to whipping.

Wedges driven  
from inboard.

Hole cut to  
examine damage  
from inboard.

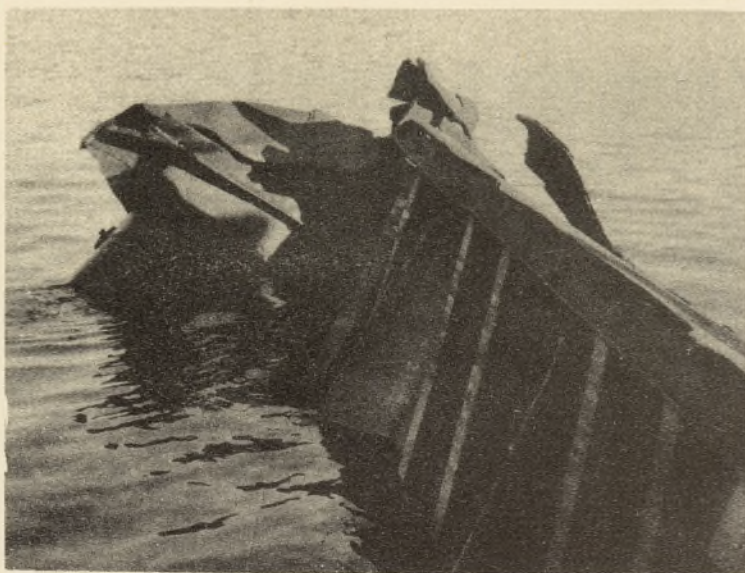
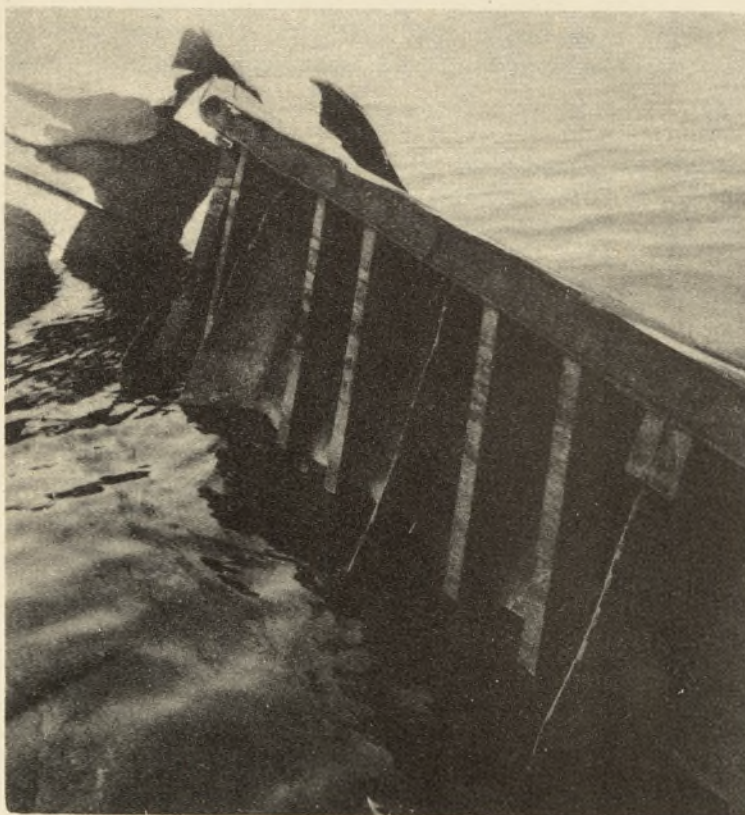
Damage at fore end due to near  
miss bomb (15<sup>th</sup> Sept. 1944).

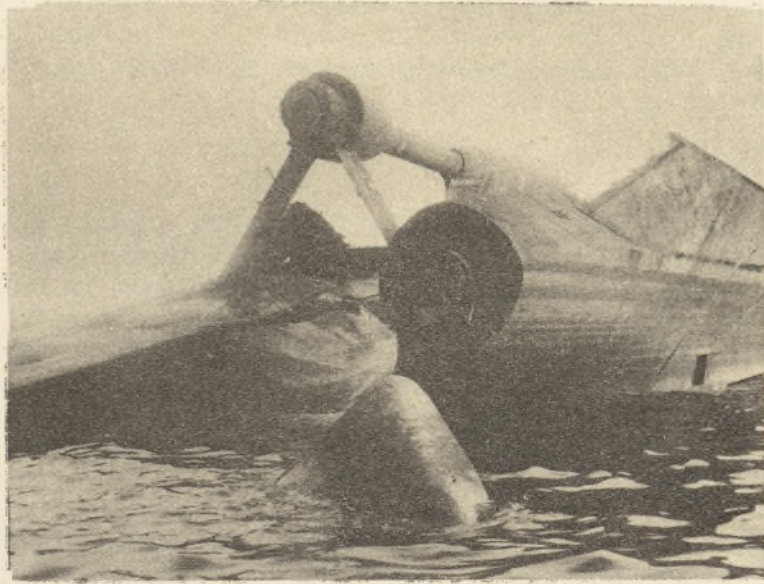
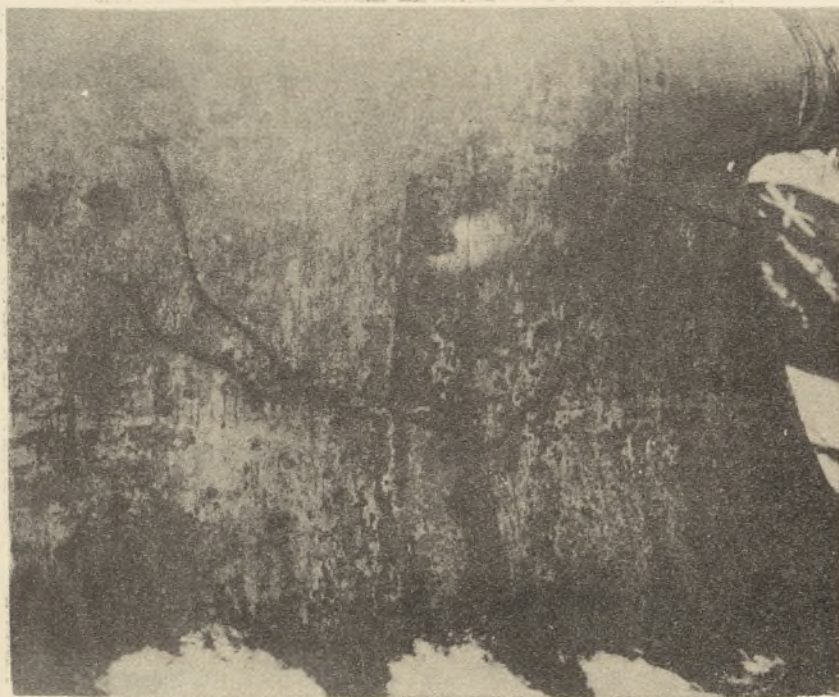
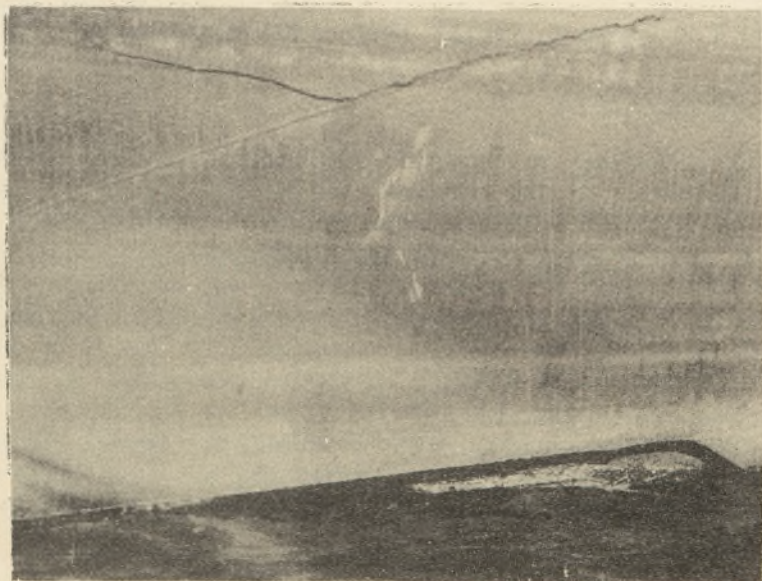
Plate B.57

Cracks in welding of hull plating  
at after end.
