TIRPITZ

An account of the various attacks
carried out by the British Armed
Forces and their effect upon the
German Battleship

Volume 2

EVIDENCE FOR DETAILED
ACCOUNTS OF DAMAGE

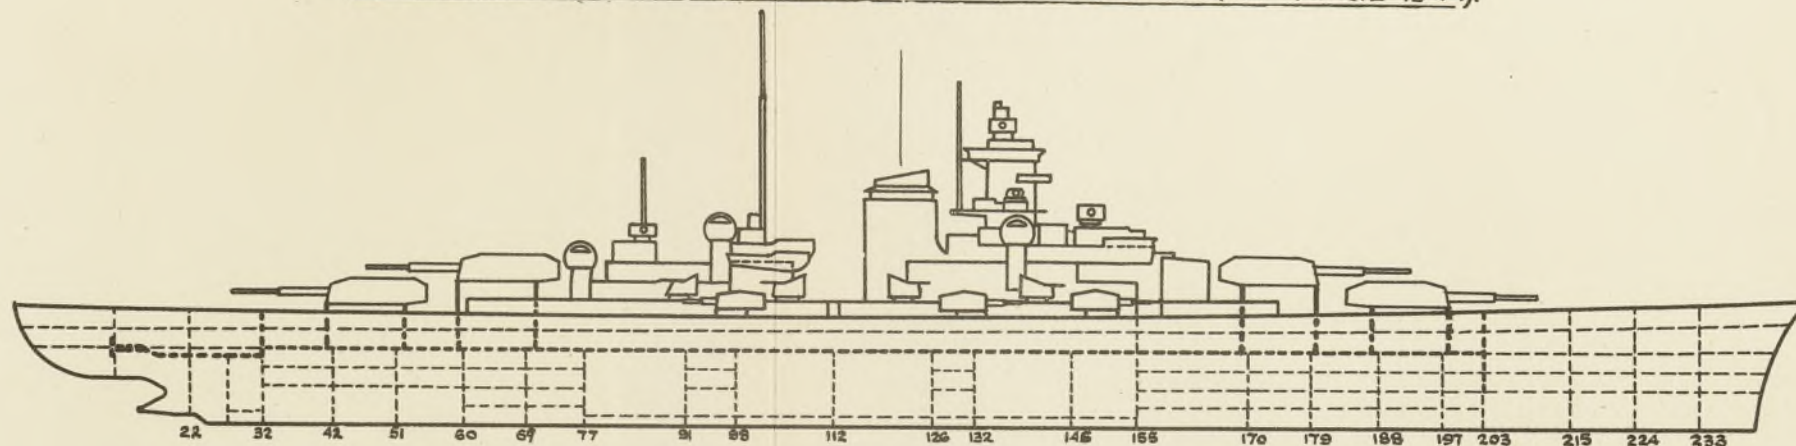
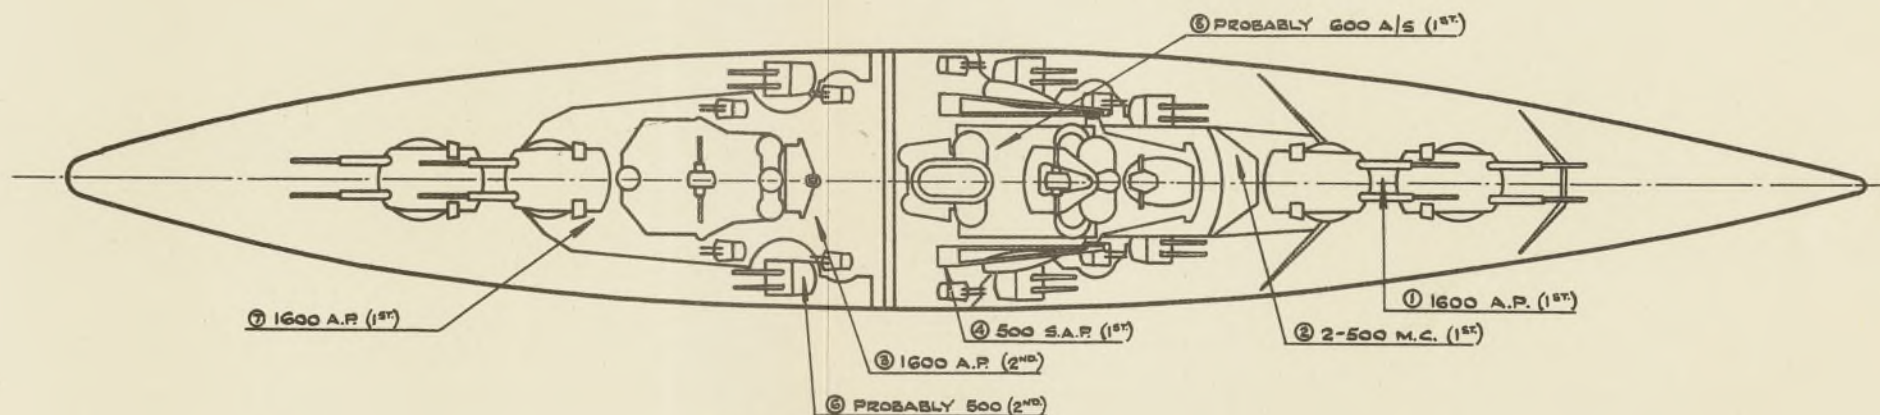
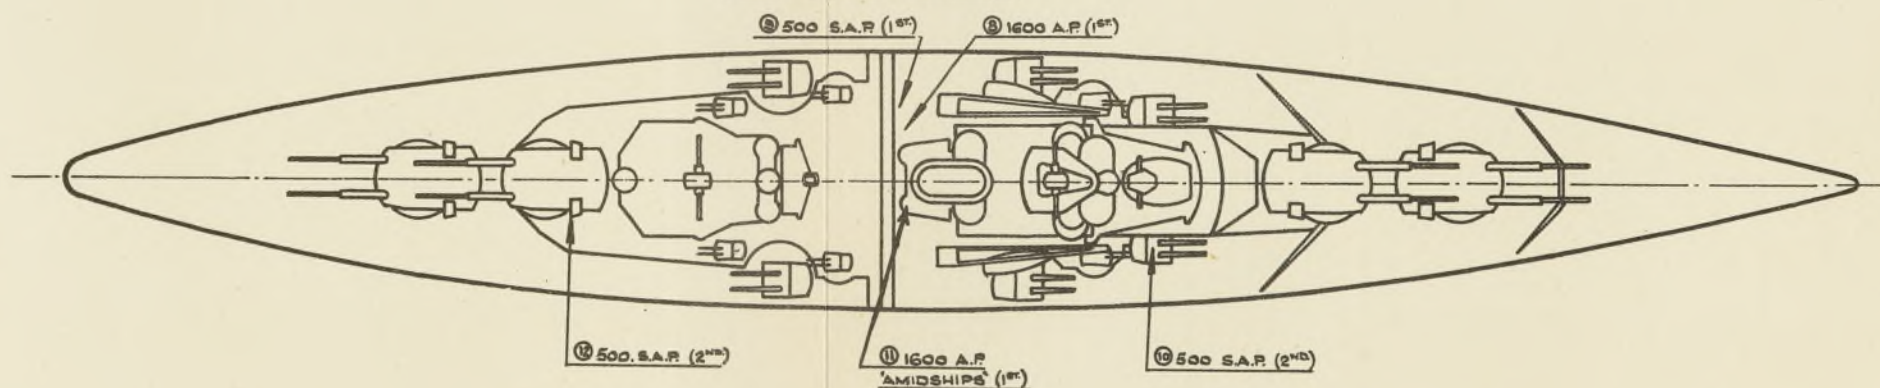
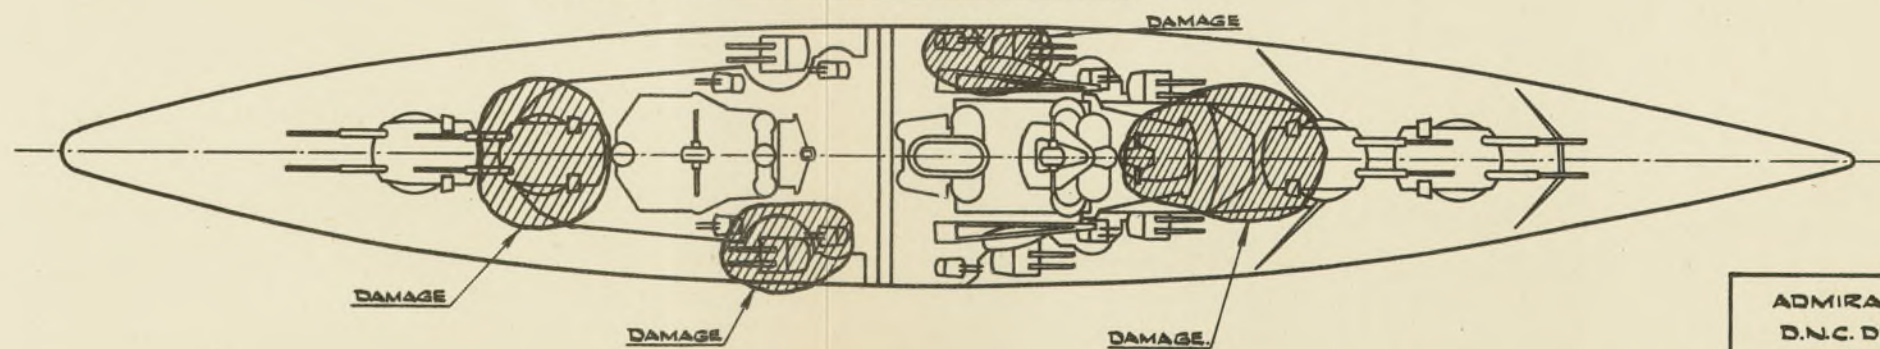
POSITIONS OF "CERTAIN" & "PROBABLE" BOMB HITS & EXTENT OF FIRE DAMAGE.

(BASED ON INFORMATION SUPPLIED BY A.W.D. ON 12TH & 14TH APRIL 1944).

CERTAIN HITS.

PROBABLE HITS.

PHOTOGRAPHIC & CREWS' EVIDENCE OF FIRE. P.R.U. EVIDENCE OF SURFACE DAMAGE.

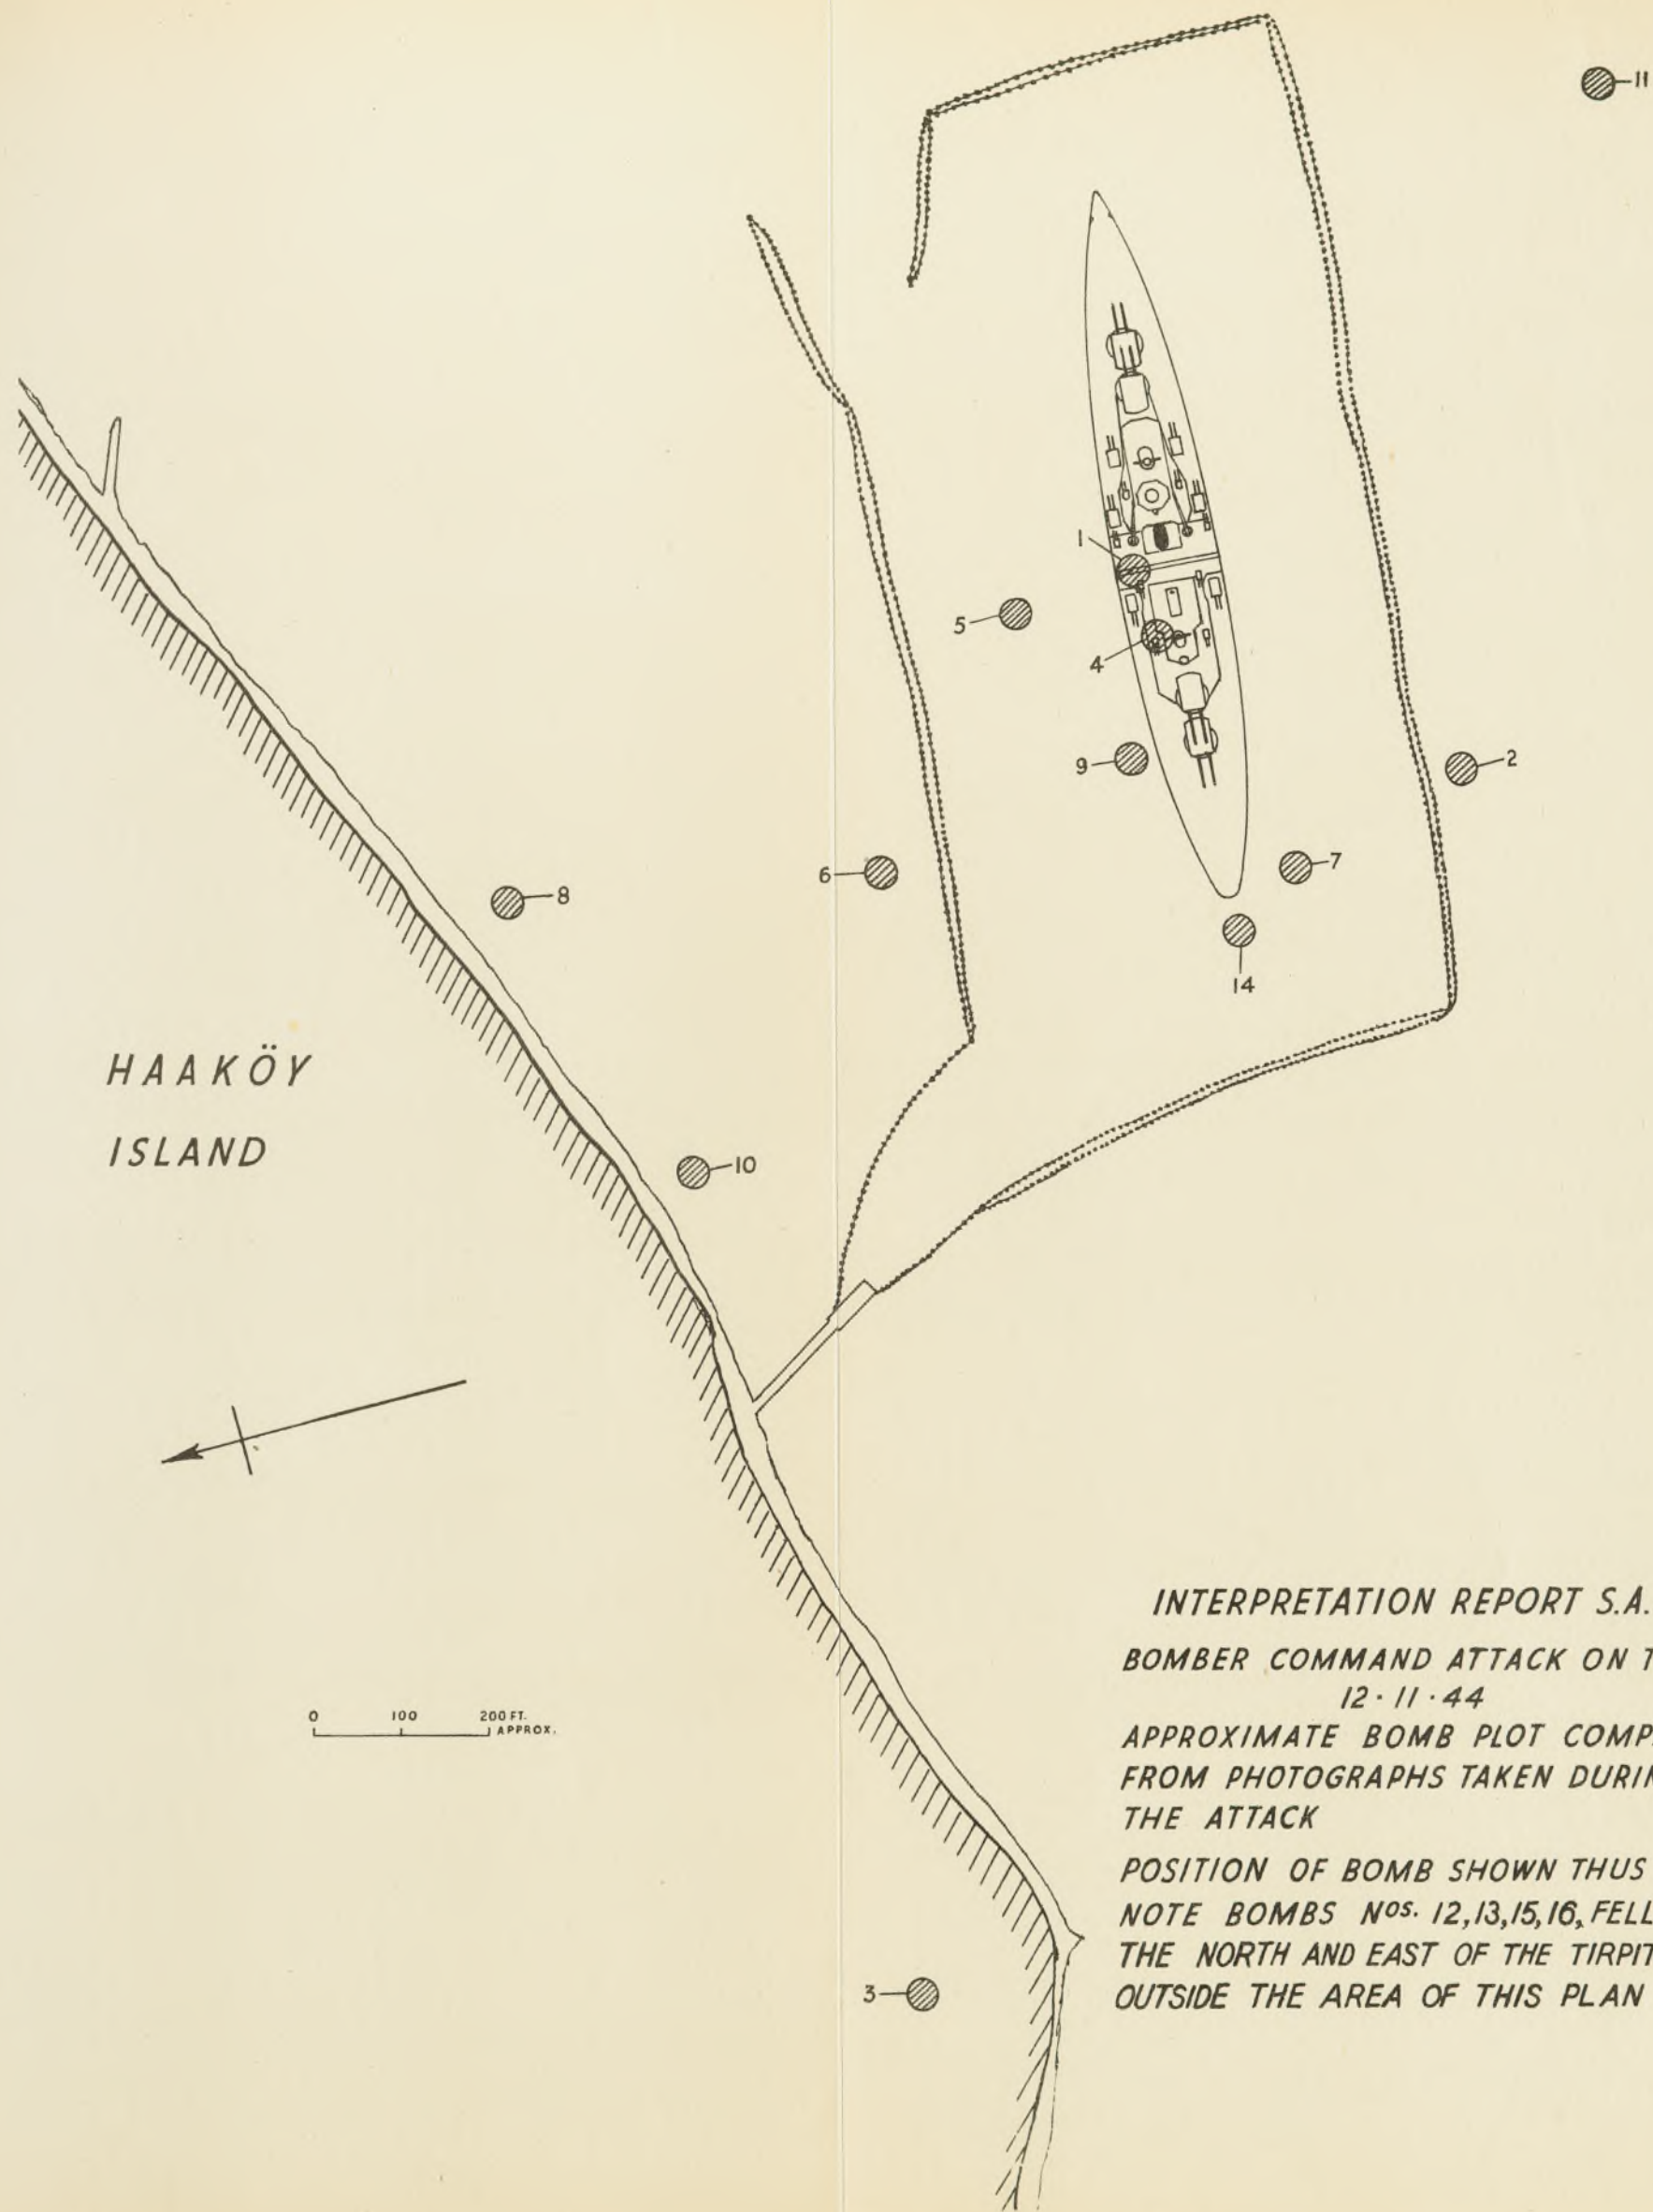
FIGURE 14.1

INTERPRETATION REPORT S.A. 2923
BOMBER COMMAND ATTACK ON TIRPITZ
12 · 11 · 44
APPROXIMATE BOMB PLOT COMPILED
FROM PHOTOGRAPHS TAKEN DURING
THE ATTACK
 POSITION OF BOMB SHOWN THUS ●
 NOTE BOMBS Nos. 12, 13, 15, 16, FELL TO
 THE NORTH AND EAST OF THE TIRPITZ
 OUTSIDE THE AREA OF THIS PLAN

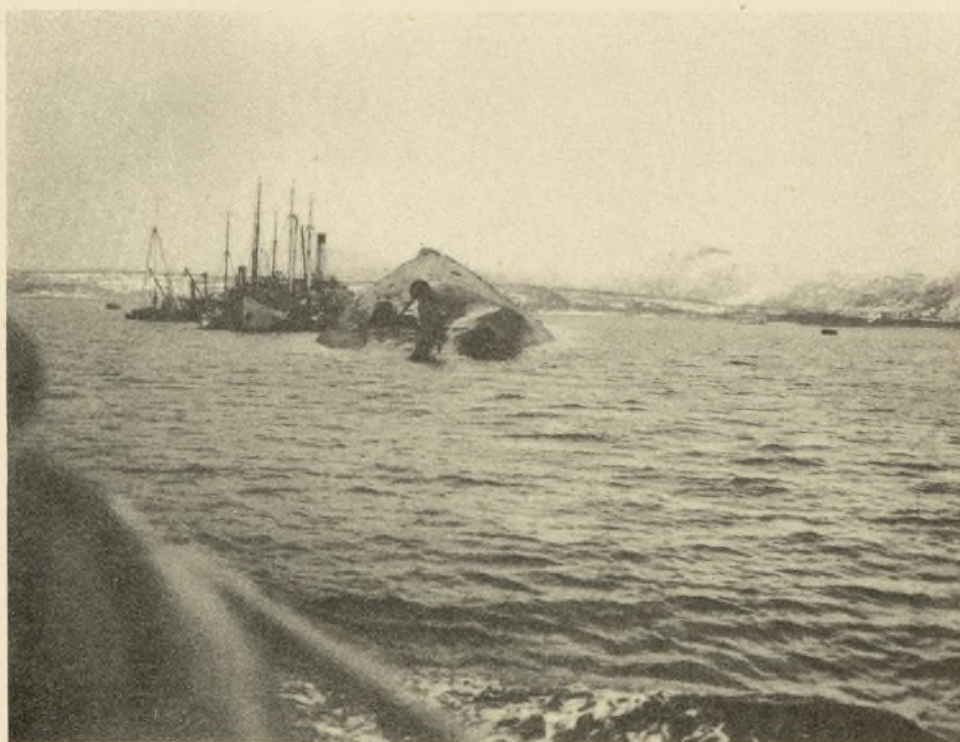
STERN VIEW SHOWING DAMAGED RUDDER AND SCREWS REMOVED

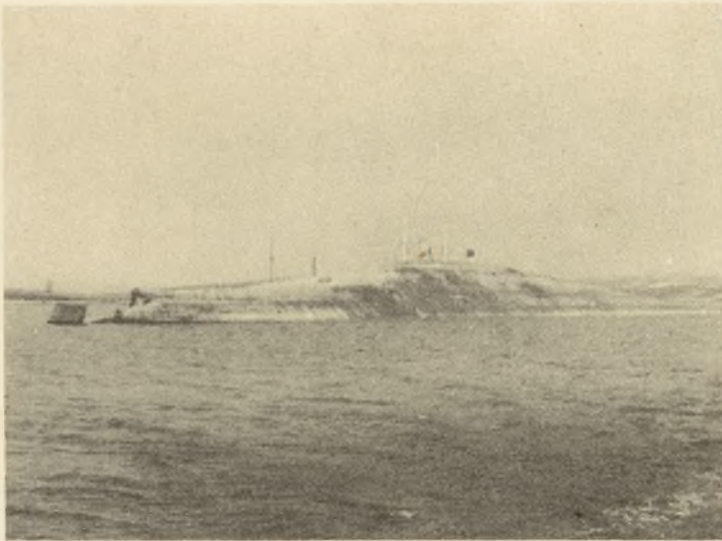
GENERAL VIEW FROM WATER SHOWING DAMAGED RUDDER

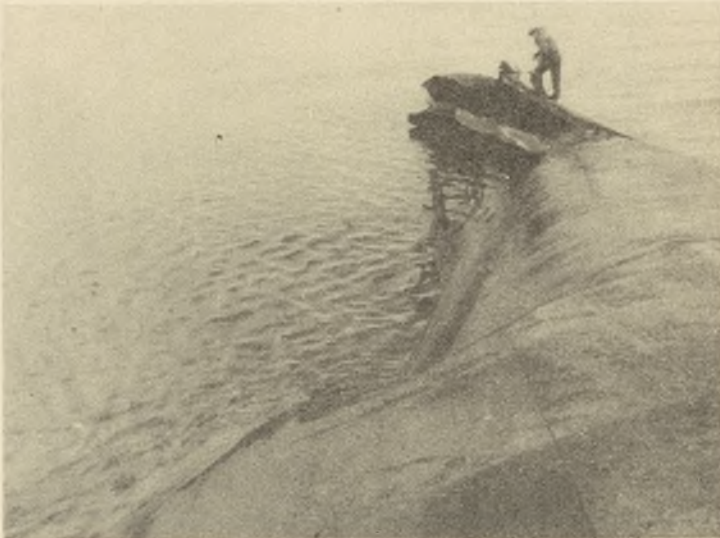
8.5 The evidence suggests that TIRPITZ received a direct hit from a 12,000 lb. bomb in a position on the middle line about 110 feet from the bow and forward of 'A' turret and possibly one fairly near miss.

VIEW OF BOW DAMAGE BY 12,000 lb. BOMB HIT
APPROX. 100 ft. DESTROYED

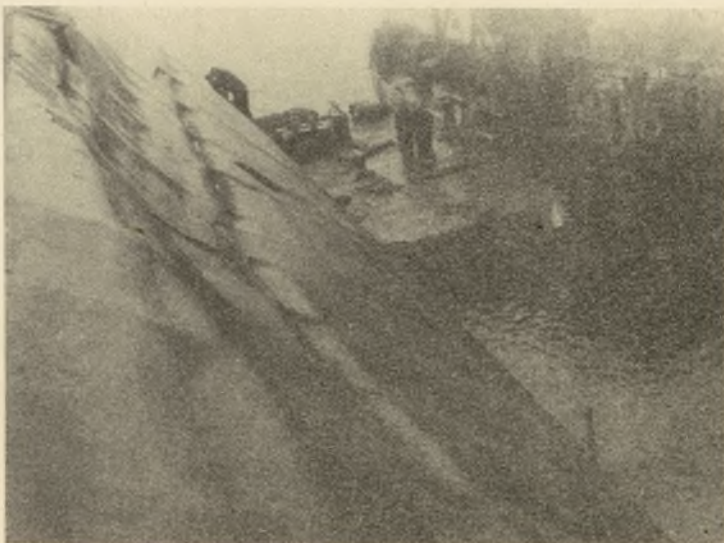
VIEW OF DAMAGE FROM 12,000 lb. NEAR MISS
DENT 50 ft. LONG AND 4 ft. DEEP

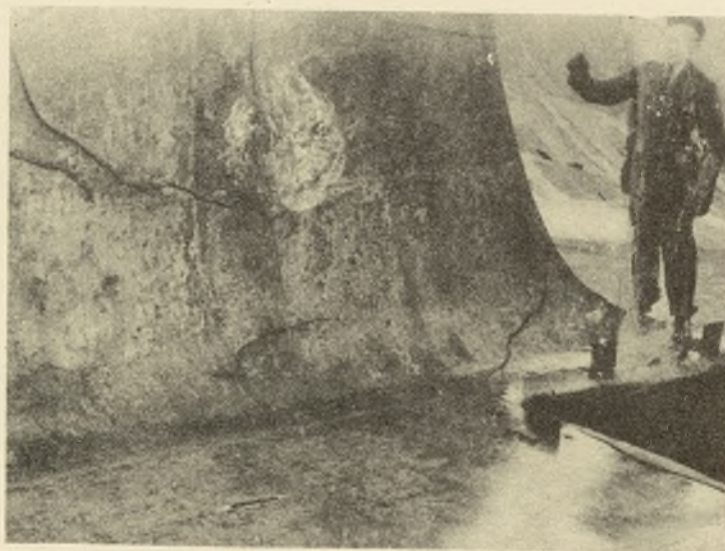
CRACKS IN STARBOARD SHAFT HOUSING
FROM MIDGET SUBMARINE ATTACK

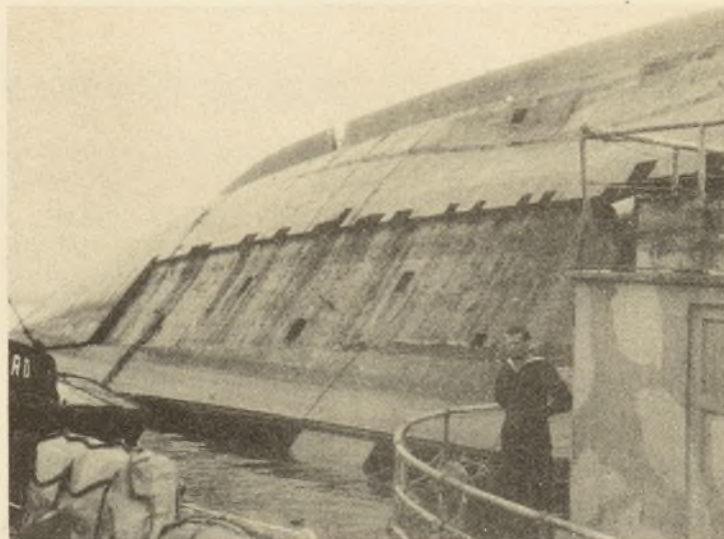
STARBOARD SIDE SHOWING ARMOUR REMOVED

←
Dent from
near miss
12,000 lb. bomb

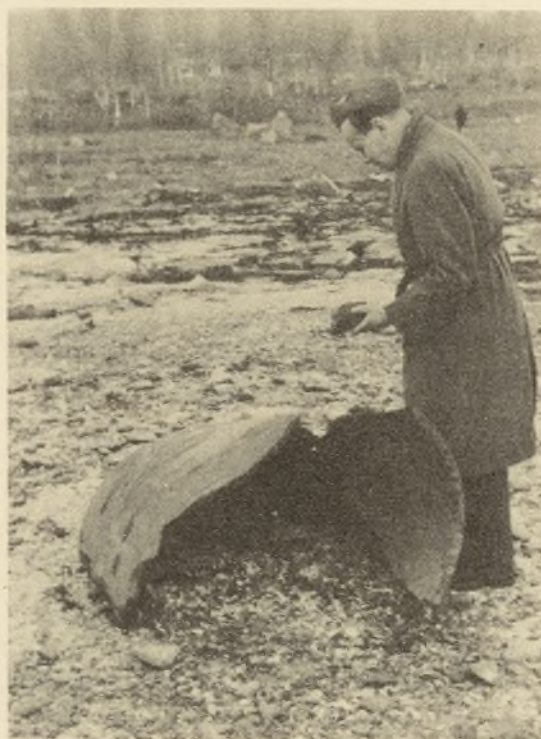
FRACTURED 12,000 lb. BOMB BODY
ON FORESHORE

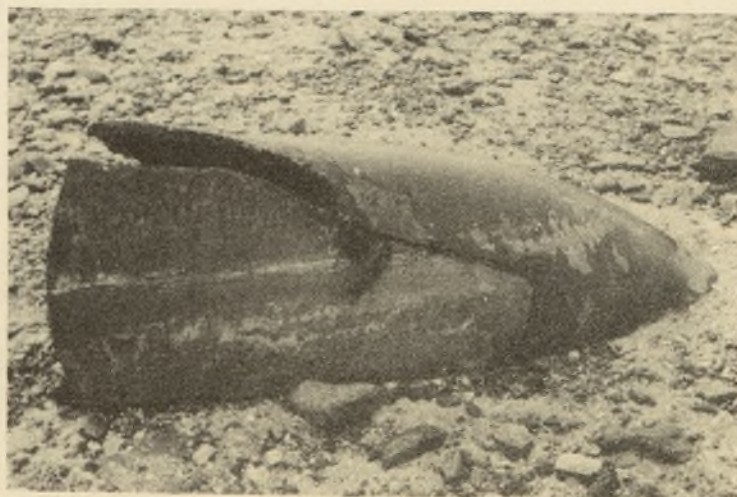
FRACTURED 12,000 lb. BOMB BODY
ON FORESHORE
