# TIRPITZ

An account of the various attacks  
carried out by the British Armed  
Forces and their effect upon the  
German Battleship

Volume 1  
REPORT AND APPENDICES

1948

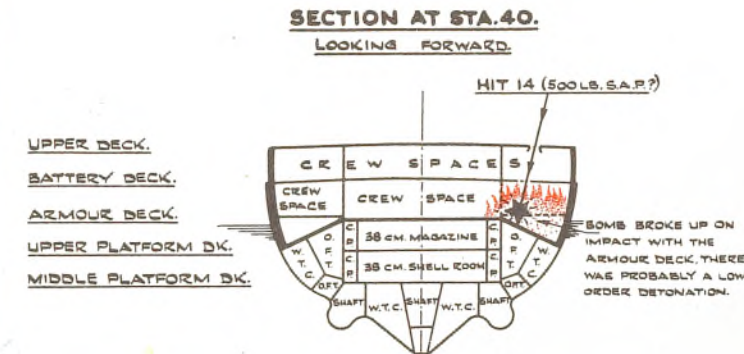
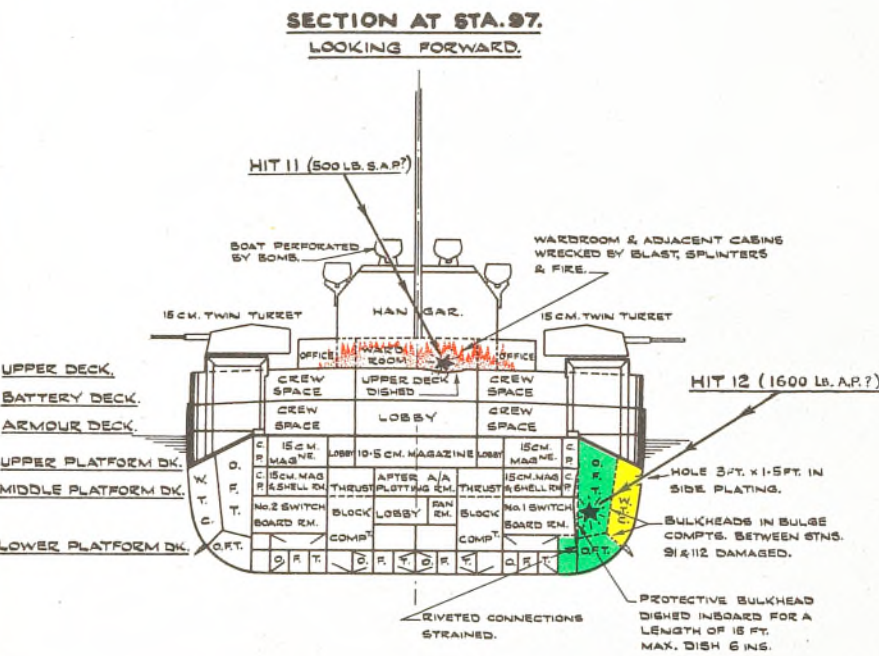
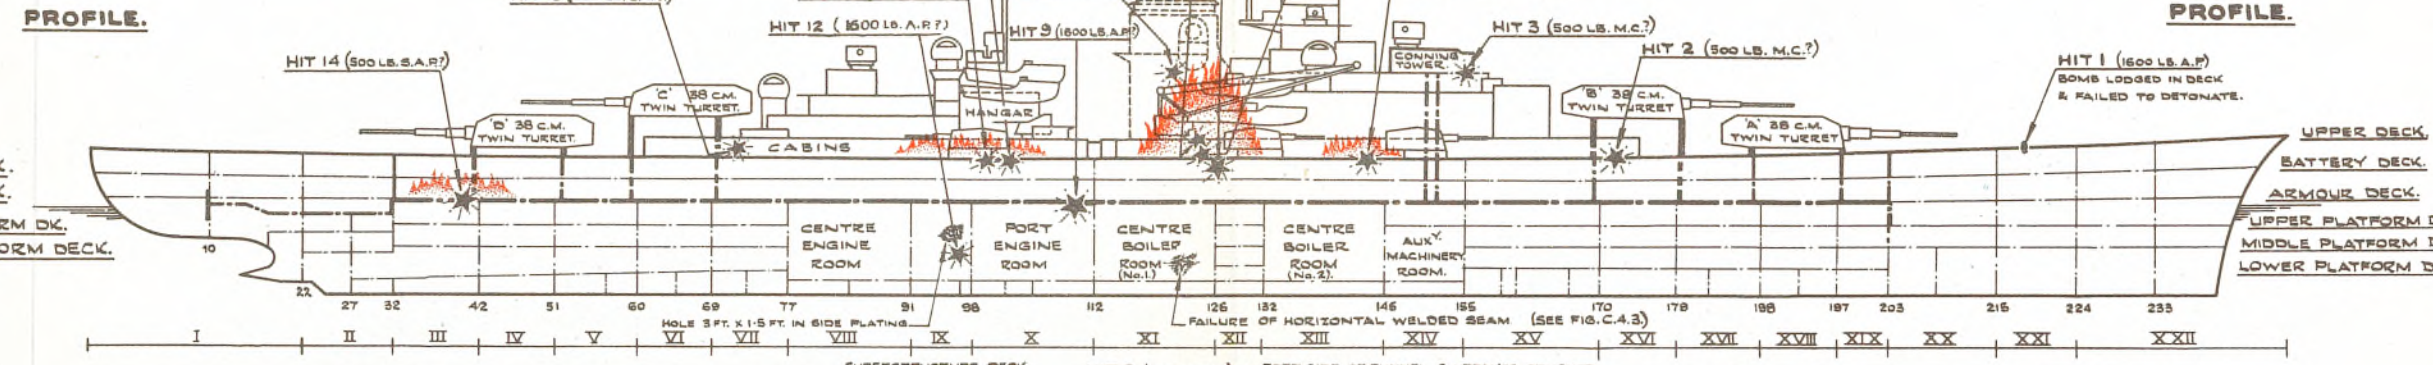
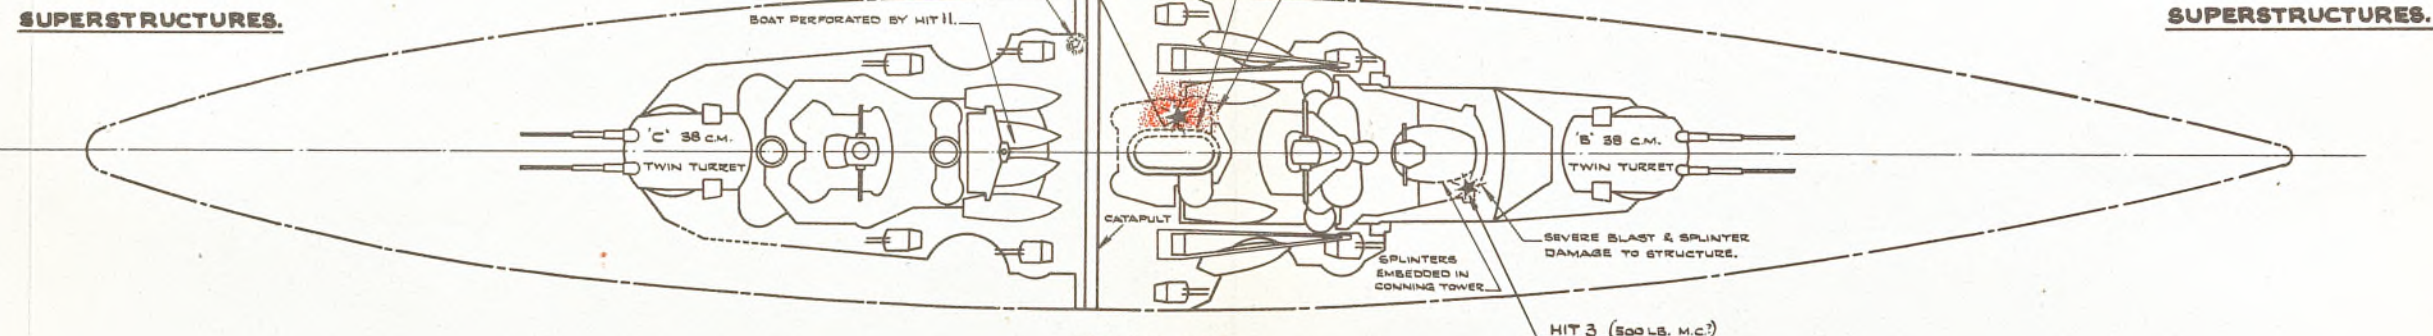
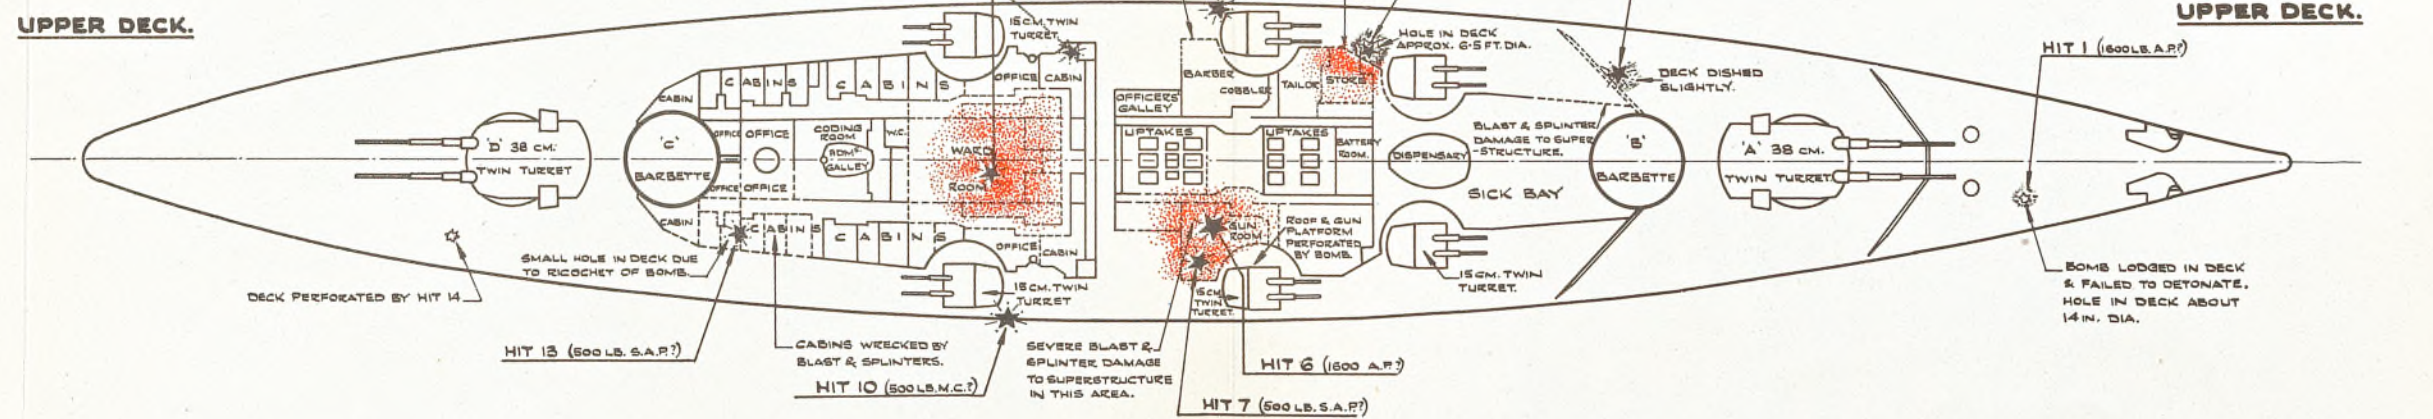
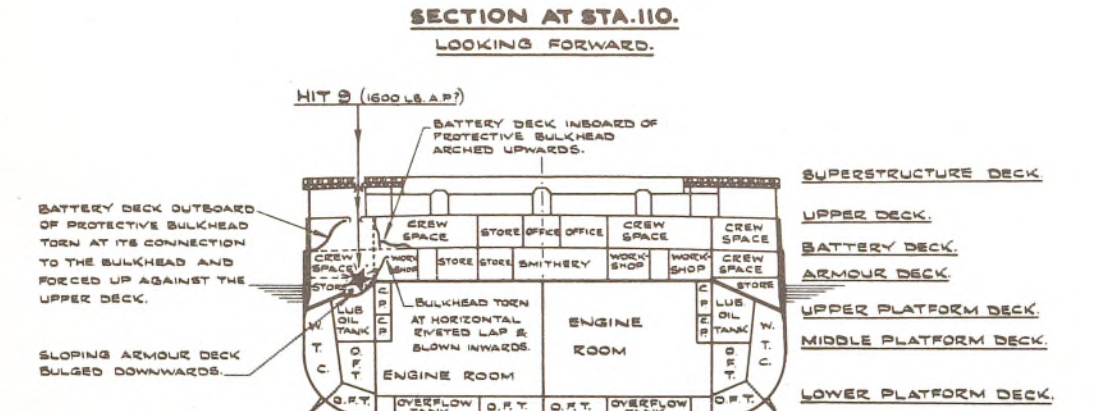
**FIGURE A.2.**

- UNCONTROLLED RAPID FLOODING.
- FLOODING INTO LIQUID PRESENT BEFORE DAMAGE.
- FIRE.

3.16 Near Misses There were probably four near misses, all off the starboard side. One, probably 500 lb. M.C. or 600 lb. A/S, detonated close to the ship's side abreast the funnel and caused a hole in the side plating (0.5 and 0.8 inch) about 7 feet long by 3 feet deep, and another abreast the outer shaft bracket caused splits and dishing in the adjacent bottom plating.

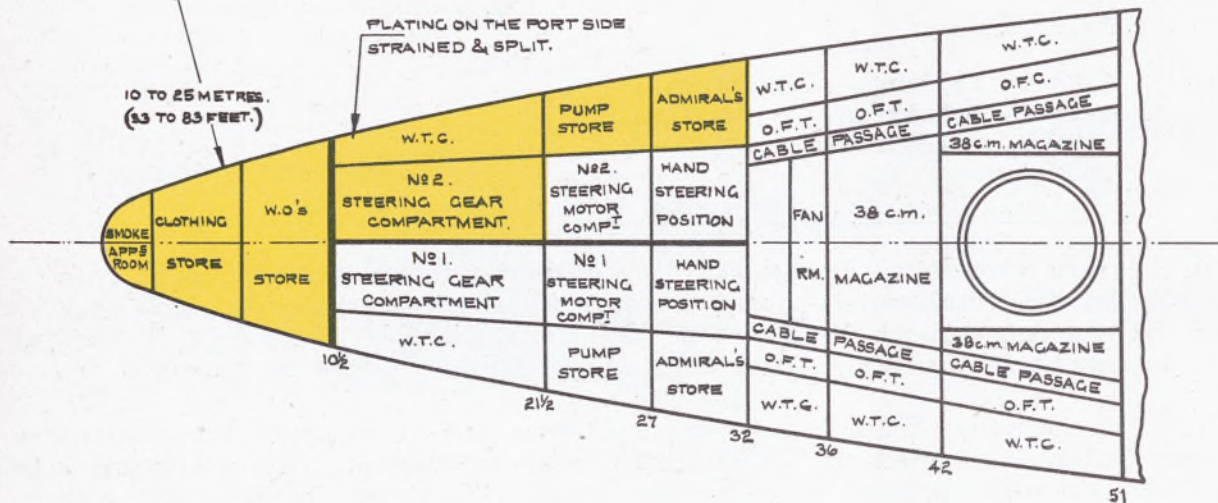
### PART PLAN OF UPPER PLATFORM DECK

ESTIMATED POSITION OF  
DETONATION OF 12,000LB.M.C.  
BOMB.

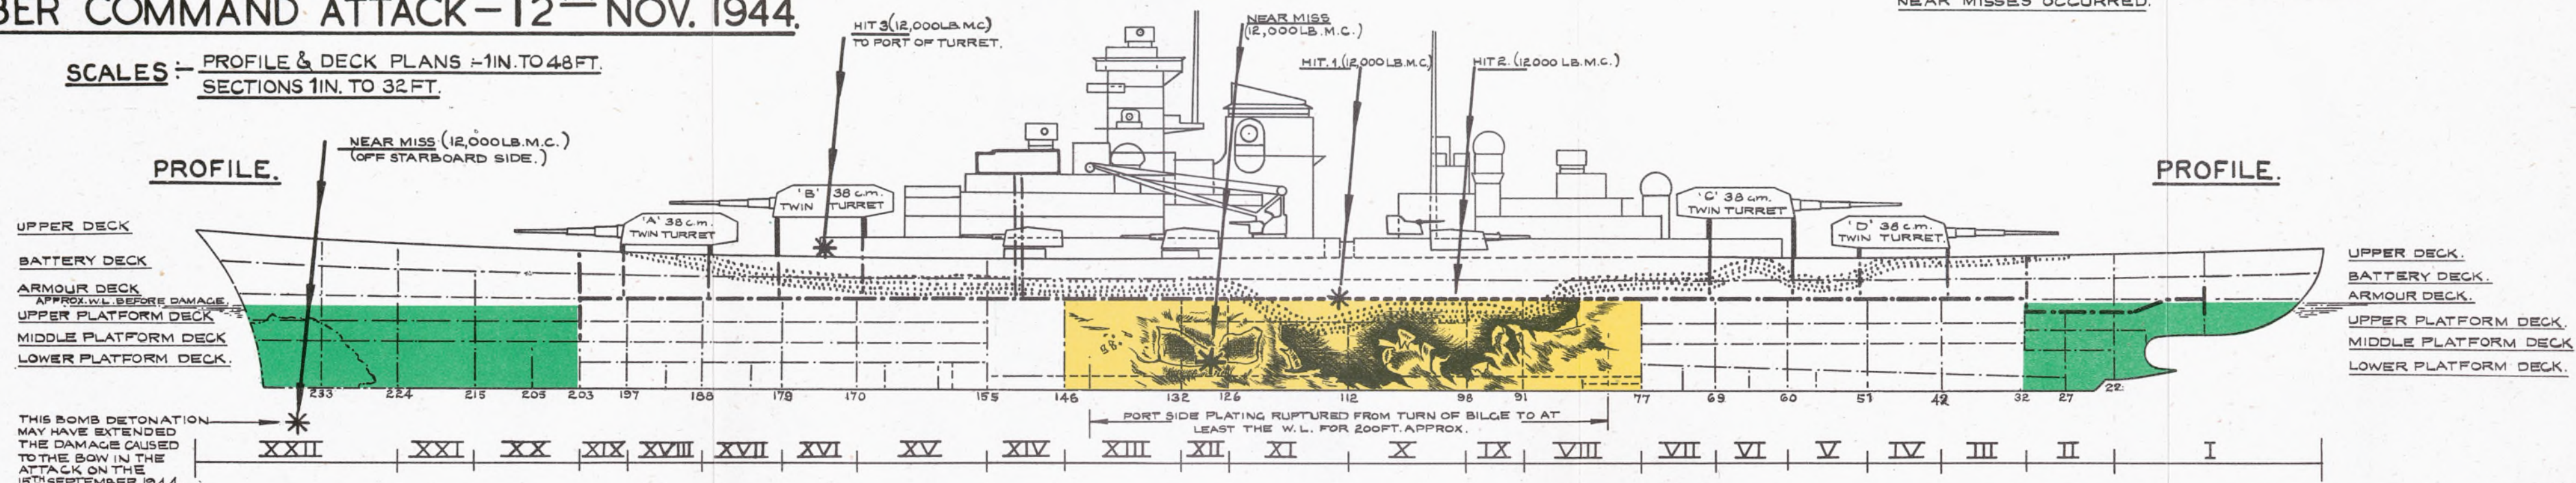
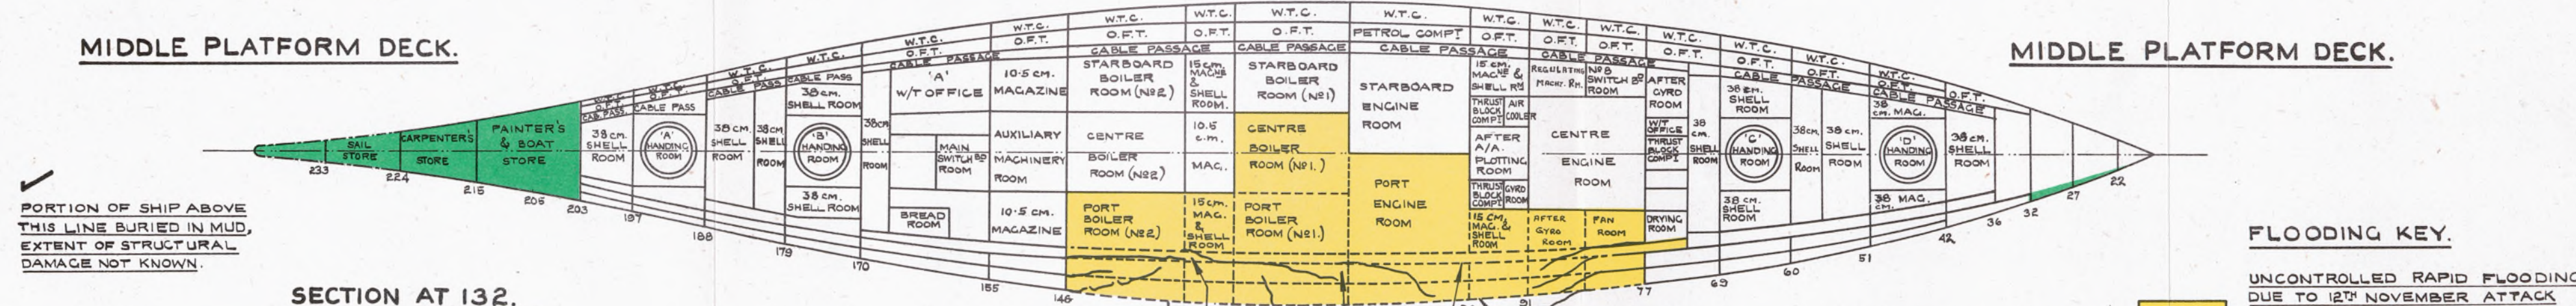
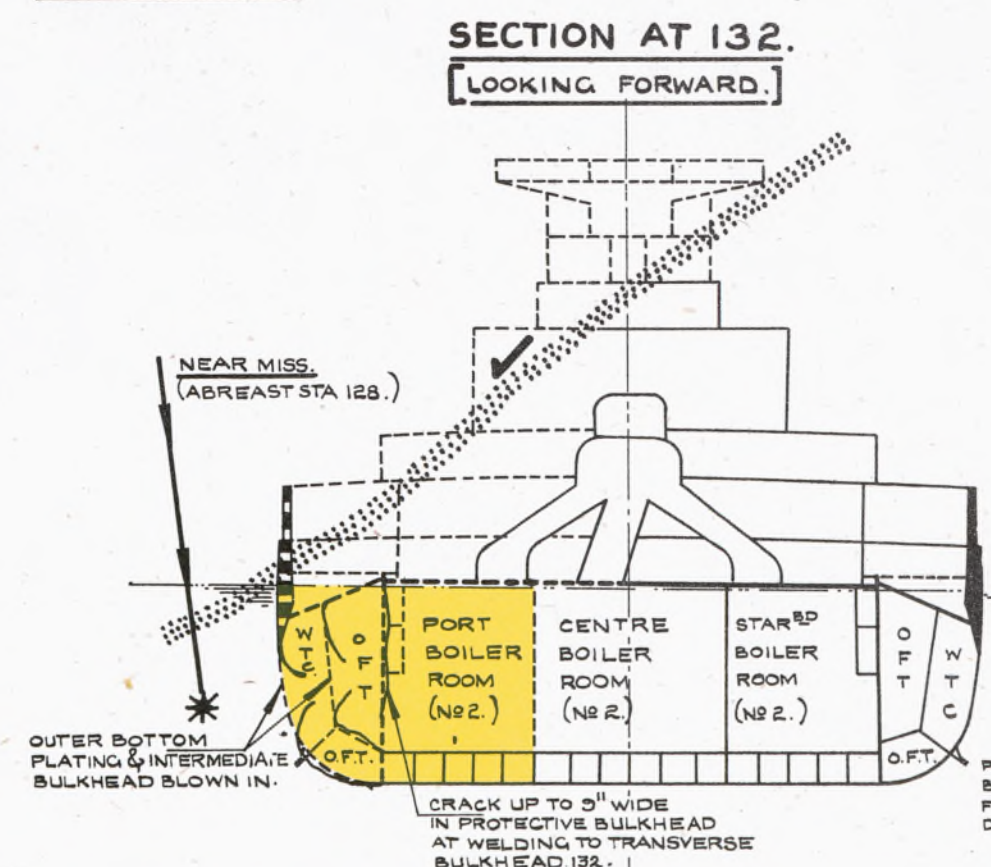
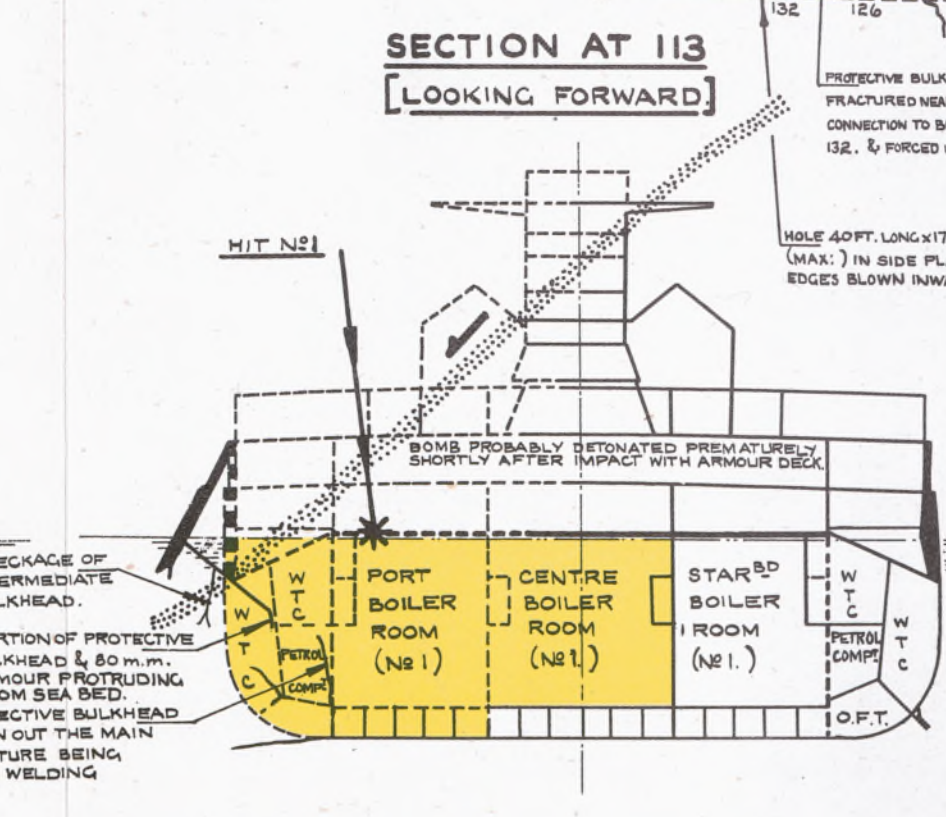
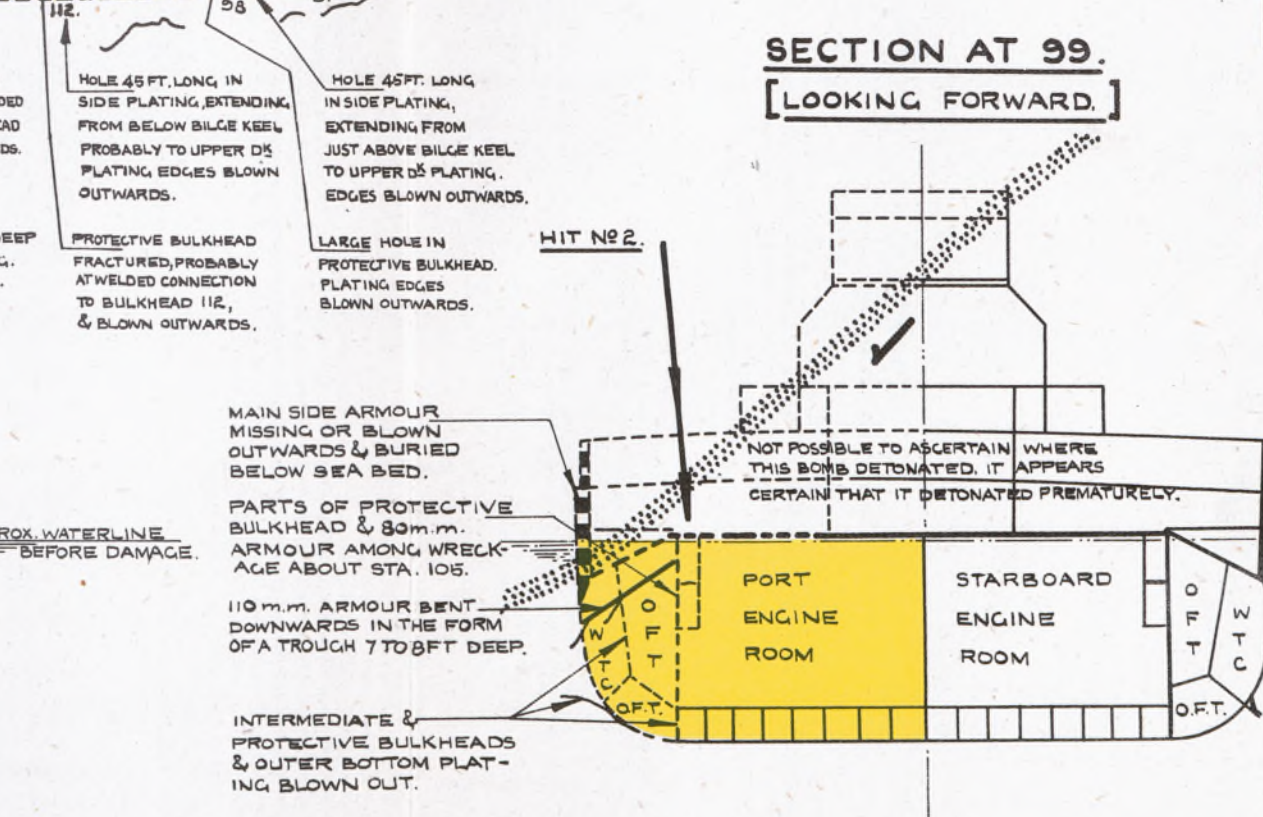
FIGURE A.6.

NOTE: - THE EXACT PATHS OF THE BOMBS ARE NOT KNOWN. THE ARROWED LINES MERELY INDICATE APPROXIMATE POSITIONS IN WHICH THE HITS & NEAR MISSES OCCURRED.

UNCONTROLLED RAPID FLOODING DUE TO 12<sup>TH</sup> NOVEMBER ATTACK (NOTE: EXTENT SHOWN IS THE MINIMUM THAT OCCURRED - SEE B.6.3. OF ENCLOSURE B.)

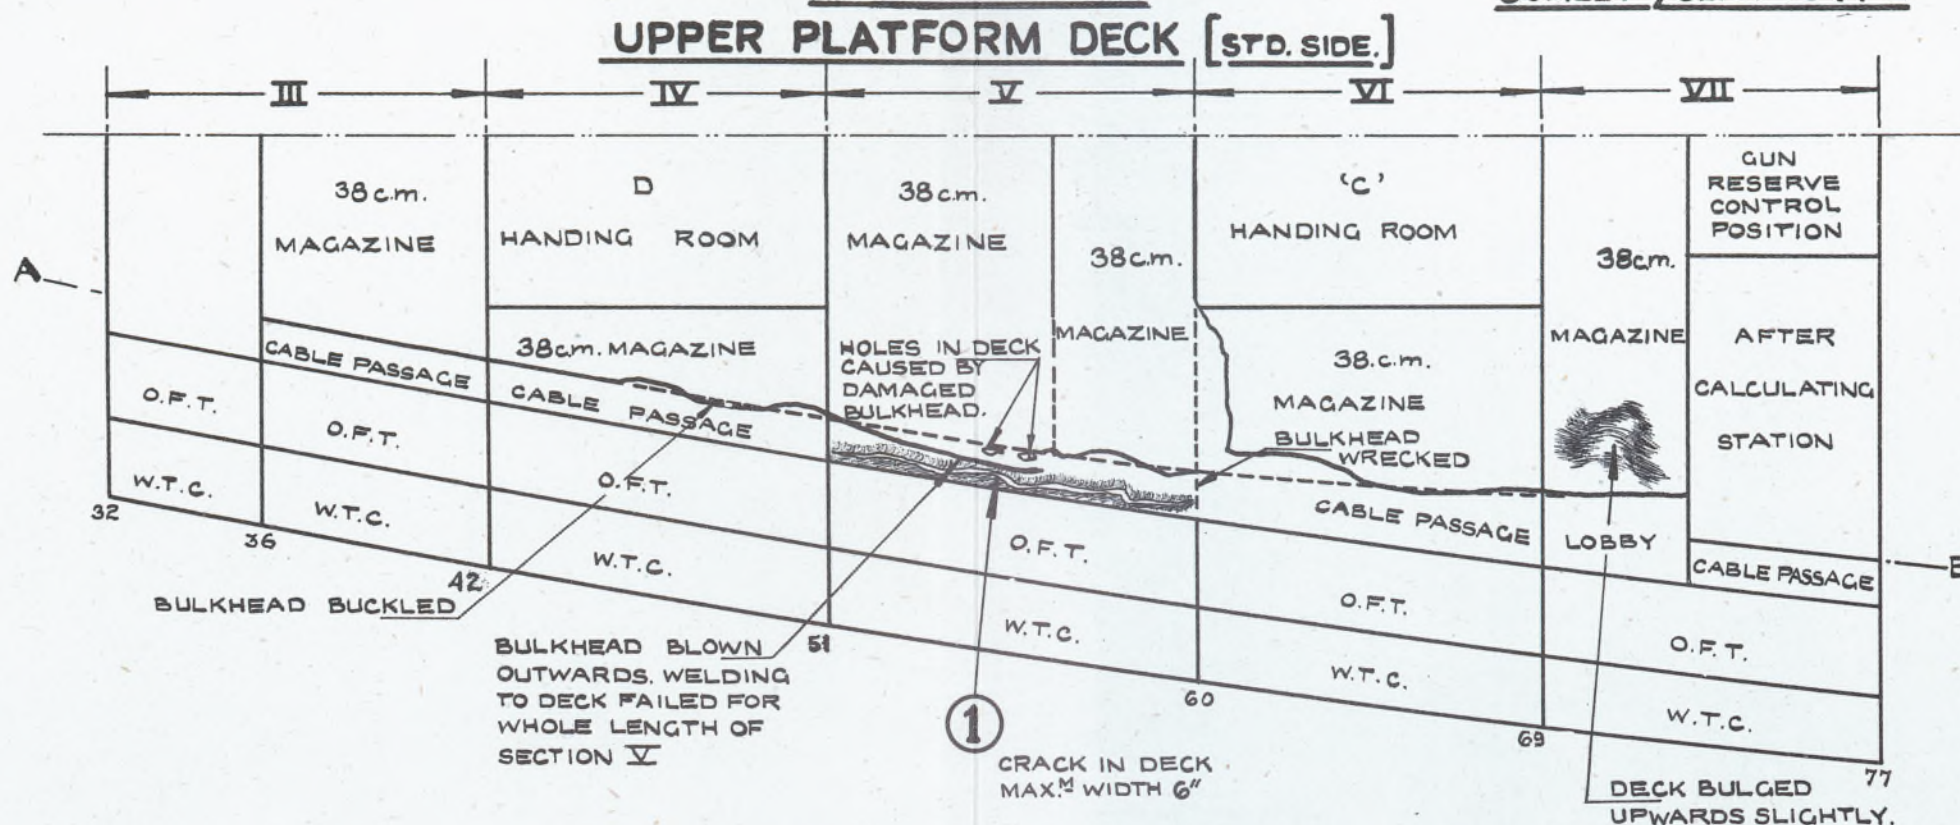
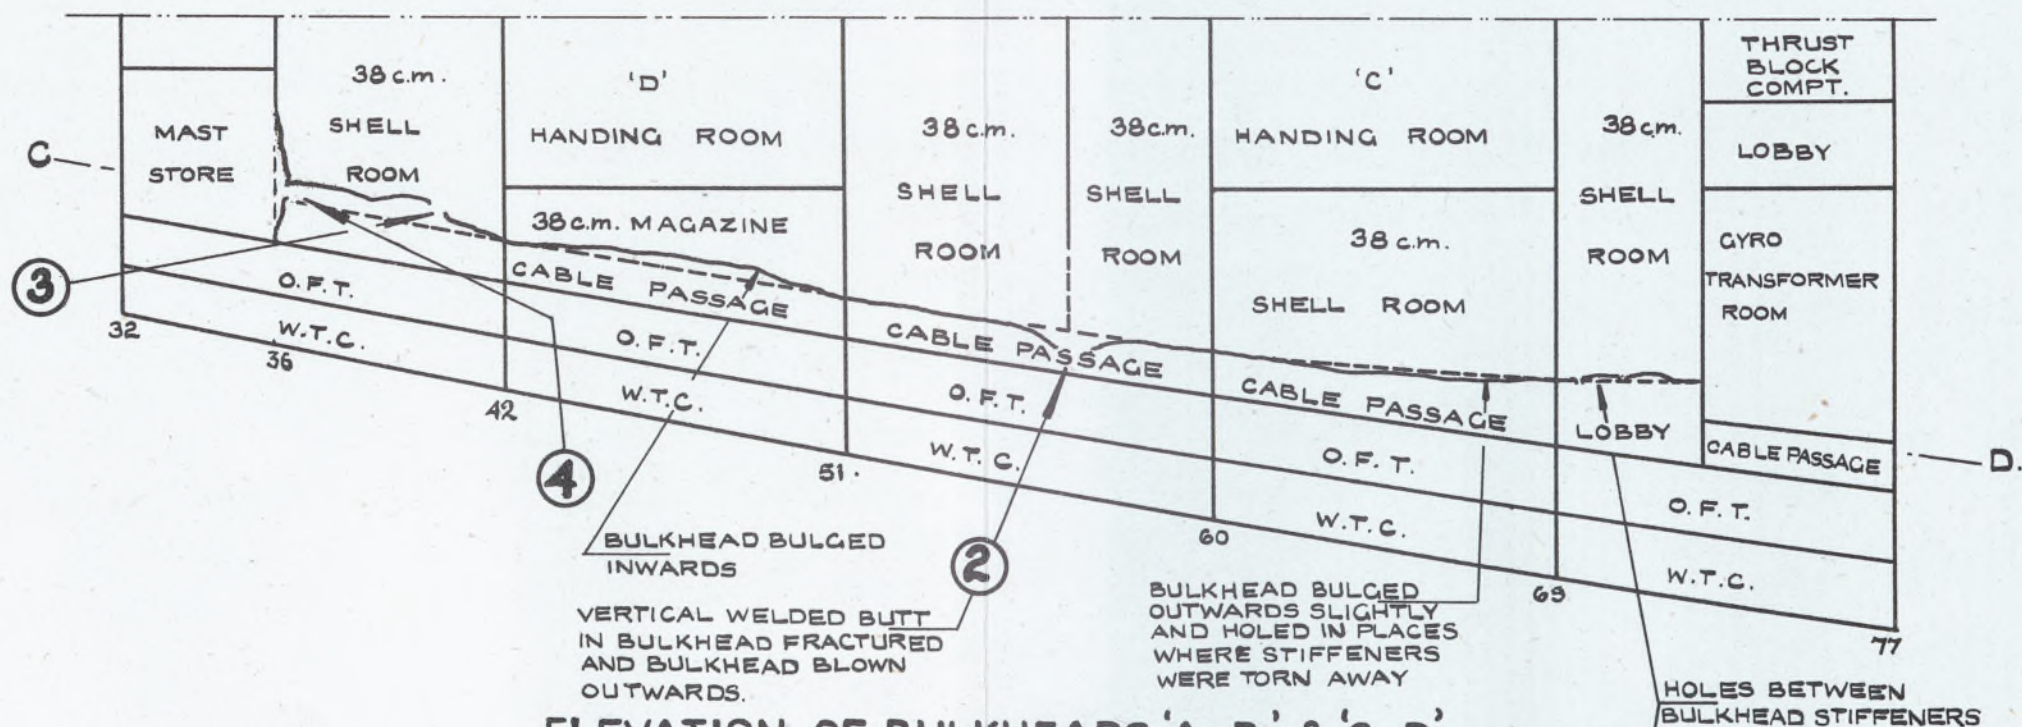
FIGURE  
B.4.2.

Crack in deck.  
(See ① fig.B.4.2)

Bulkhead to  
shell room  
between C and  
D turrets blown  
out; crack down  
line of welding.  
(See ② fig.B.4.2.)

Shell room bulkhead fractured along line of vertical welding and blown in-board.

2.1 It was found that considerable damage had been caused by an internal explosion in the vicinity of 'C' and 'D' magazines. The majority of this damage was underwater at the time of the survey, but it was possible at very low water to get access to the area through holes burnt for escape purposes and along the cable passages. Photographs on Plates B.4.2(a) and B.4.2(b) show details of the damage found and Figure B.4.2 shows the general extent.

2.2 The seat of the explosion was in the magazine between turrets 'C' and 'D'. On the starboard side of the ship the explosion damaged the inboard bulkhead of the cable passage and vented down the cable passage damaging decks and bulkheads as far aft as bulkhead 36 and as far forward as bulkhead 68.5. In both cable passages there were watertight doors at each transverse bulkhead. The hinges of all these doors in the area were broken and one of the doors was blown aft about 27 feet. The longitudinal bulkhead forming the starboard boundary of the shell room just forward of turret 'C' had a number of holes blown in it and gave the impression that a number of explosions had occurred in the shell room rather than one large explosion such as had occurred in the magazine. The products of the explosion had had sufficient force however to blow the watertight door in the main transverse bulkhead 68.8 on the lower platform deck a distance of 20 feet aft. Everything in this shell room had been blackened by the products of the explosion.

## DAMAGE DUE TO INTERNAL EXPLOSION AT AFTER END.

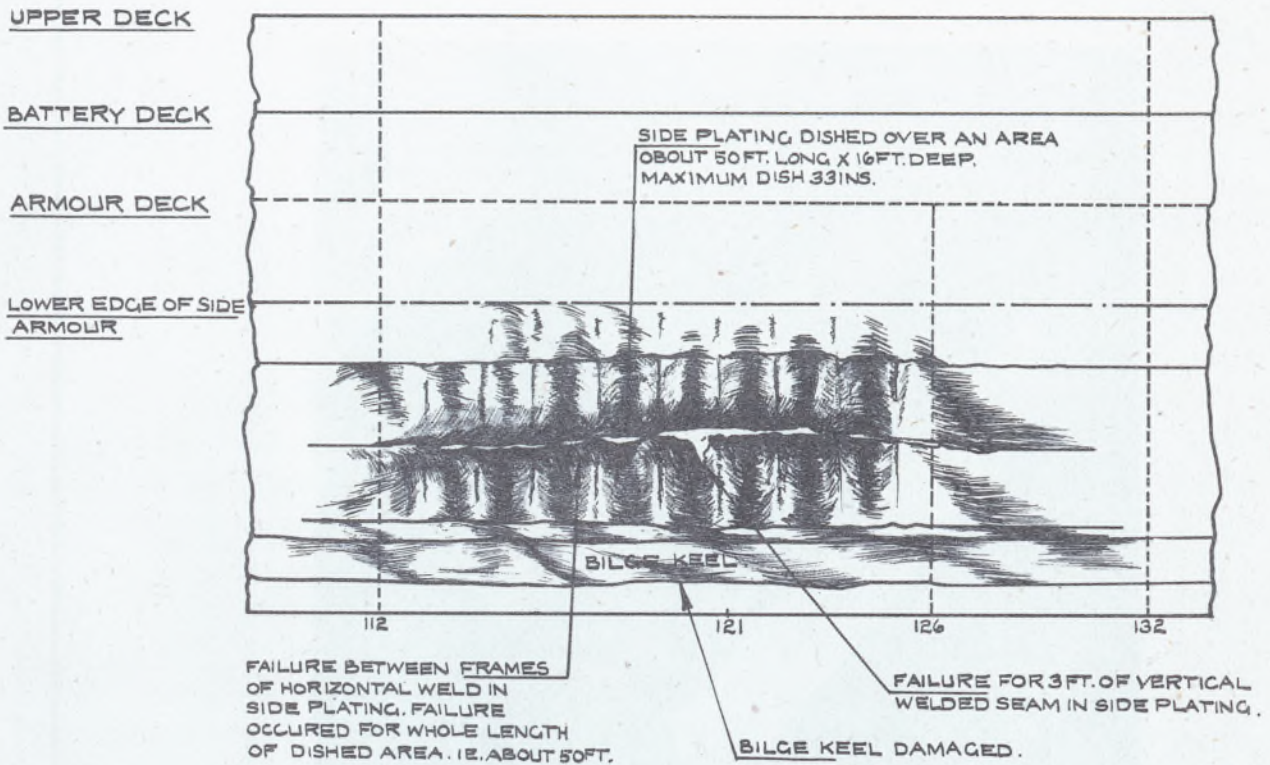
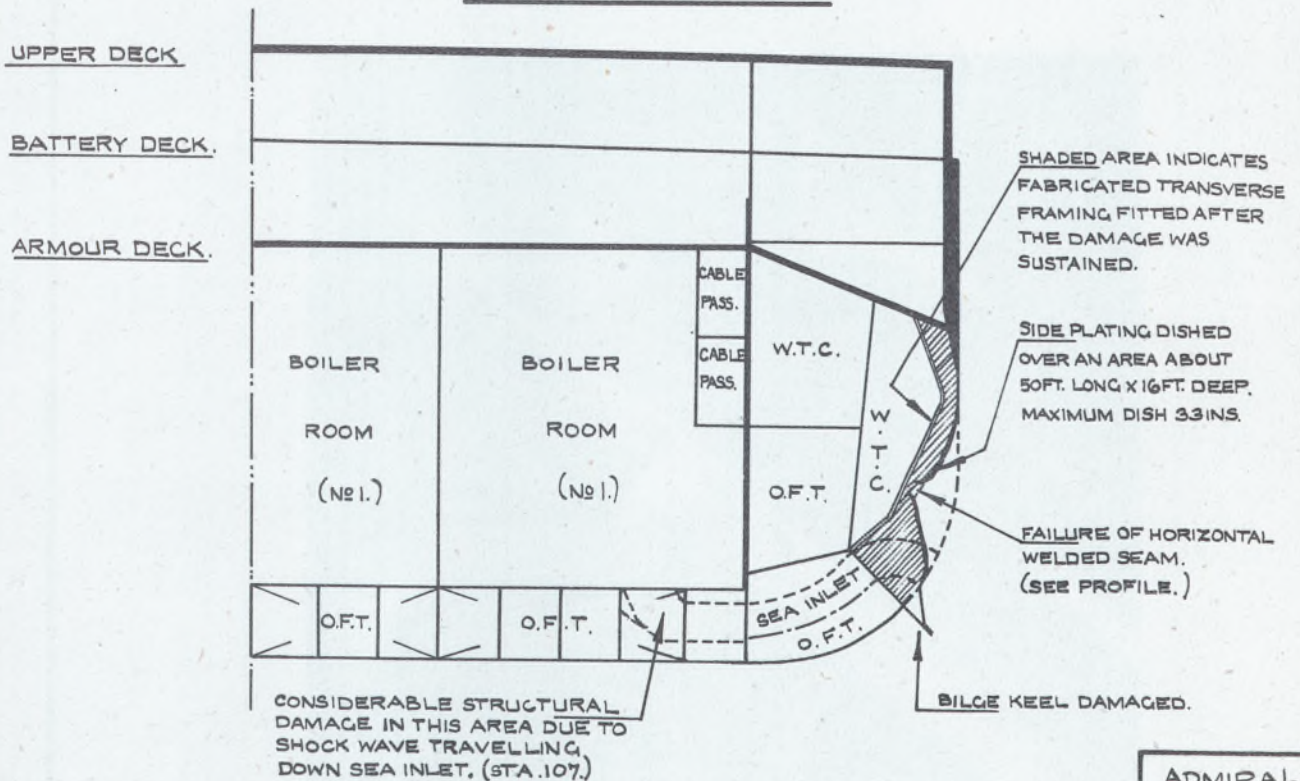
4.1 Figure B.4.4 shows damage caused by a near miss which detonated off the starboard side abreast the funnel. The dishing in the outer bottom plating extended over an area of 50 feet x 16 feet, the maximum inboard deflection at the centre being about 33 inches. Some authorities have wrongly supposed that this damage had been caused by a near miss with Tallboy. The bomb had caused splits in way of welding over a considerable area and these splits had been made watertight by driving in steel liners and welding on patches under water. The repair had been continued from inboard after pumping out the compartment.

Damage to plating and frames was extensive and the repairs must have taken many weeks (see Section 7 of Volume 2). No attempt had been made to alter the shape of the bulge in the bottom plating and fabricated transverse frames had been built around it. The pressure pulse from this near miss had caused considerable damage at the inboard end of the sea inlet which was close to the above-mentioned damage. As this was quite inaccessible no repair work had been carried out.
